Access Compliance Report

Public Rights-of-Way

(Curb Ramps)

Intersection ID: 52698	Main Street: JOSEPHINE_CT	Cross Street: MECKLENBURG_AV	Location: SE
ADA ID: 3BB1CD85C660	Ramp Type: PerpDiag	Initial Pass/Fail: Fail	Overall Compliance: No
Severity Score: 8.75			
Codes/Mitigation Info/Possible Solution		Field Measurements/Component Compliance

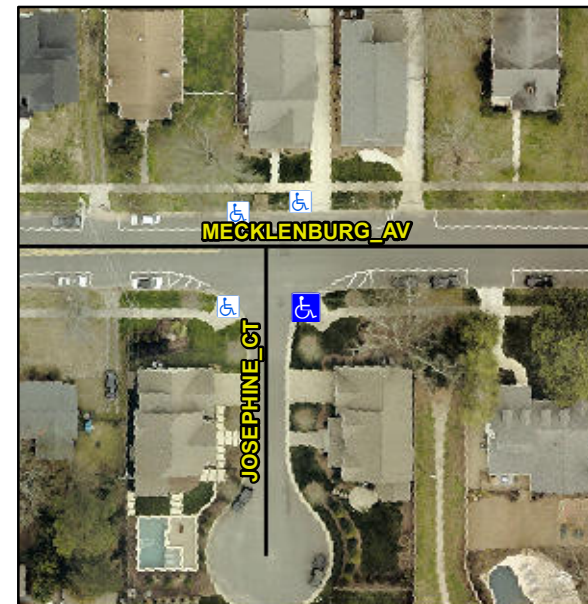
Compliance	Description	Data	Compliance	Description	Data
N/A	Ramp Length (in)	117.0	Yes	Ramp Slope (%)	6.5
No	Ramp Width (in)	47.0	Yes	Ramp XSlope (%)	1.0
N/A	Flare Type LT	N/A	N/A	Flare Type RT	N/A
N/A	Flare Slope LT (%)	N/A	N/A	Flare Slope RT (%)	N/A
N/A	Flare Traversable LT?	N/A	N/A	Flare Traversable RT?	N/A
N/A	Landing Length (in)	N/A	N/A	DWS Provided?	N/A
N/A	Landing Width (in)	N/A	N/A	DWS Contrast?	N/A
N/A	Landing Slope (%)	N/A	N/A	DWS Length (in)	N/A
N/A	Landing X Slope (%)	N/A	N/A	DWS Full Width?	N/A
N/A	Landing Curb? (Y/N)	N/A	N/A	DWS Offset (in)	N/A
N/A	Shared Landing?	N/A			
N/A	Gutter Ponding?	N/A	N/A	Gutter Slope (%)	N/A
N/A	Gutter Lip Ht (in)	N/A	N/A	Gutter X Slope (%)	N/A
N/A	Painted X Walk1?	No	N/A	Painted X Walk2?	No
	X Walk 1 Direction	To N		X Walk 2 Direction	To W
N/A	X Walk 1 Width (in)	N/A	N/A	X Walk 2 Width (in)	N/A
	X Walk 1 Slope (%)	1.8		X Walk 2 Slope (%)	0.8
	X Walk 1 X Slope (%)	0.4		X Walk 2 X Slope (%)	0.5

N/A	Ramp inside XWalk1?	N/A	N/A	Ramp inside XWalk2?	N/A
	Road Slope (%)	0.7	N/A	Clear Space?	N/A
	Road X Slope (%)	0.9	N/A	Clear Space to XWalk (in)	N/A
N/A	Any Obstructions?	N/A	N/A	Storm Grate/Utility Hazard?	N/A
	Obstruction Type			Storm Grate/Utility Type	
		N/A			N/A
		Yes		Surface Condition? (G/P)	Good

Possible Solutions:

Remove & Replace Curb Ramp With Two New Directional Ramps or Equivalent.
