Access Compliance Report

Public Rights-of-Way

Intersection ID: 14831	Main Street: BARFIELD_DR	Cross Street: MANCHESTER_DR	Location: W
ADA ID: 3BBD13CC472C	Ramp Type: BlendTrans1	Initial Pass/Fail: Fail	Overall Compliance: No
Severity Score: 10			
Codes/Mitigation Info/Possible Solution		Field Measurements/Component Compliance

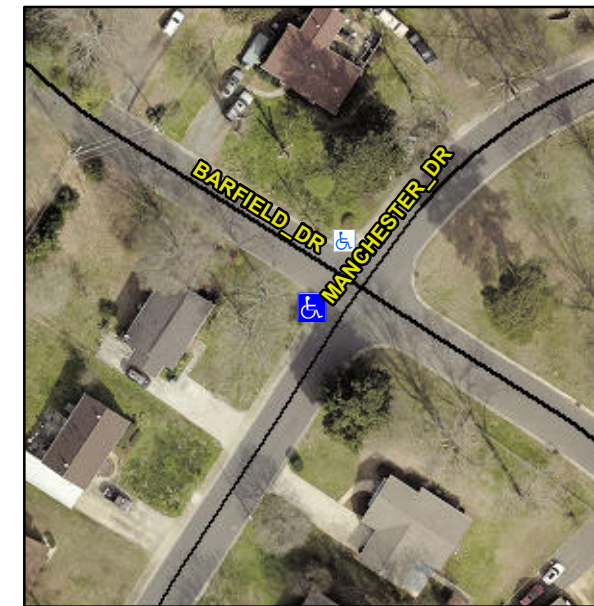
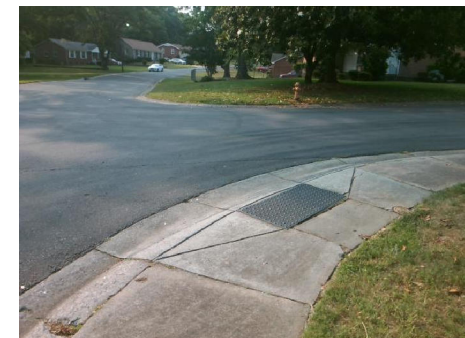
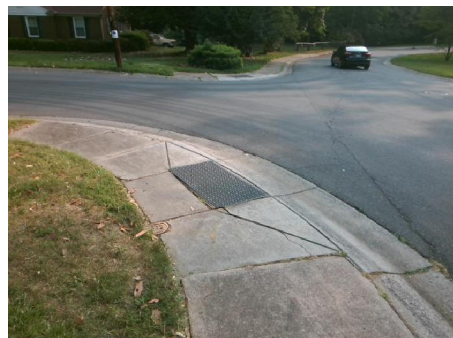
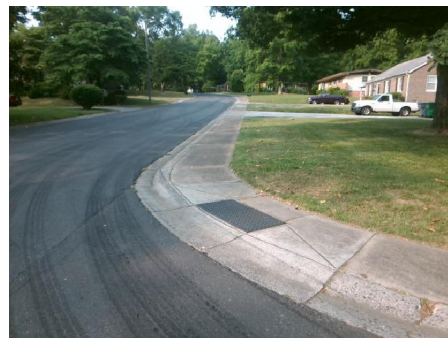
Not Found, R304.5.1, R304.5.3

Compliance	Description	Data	Compliance	Description	Data
N/A	Ramp Length (in)	49.0	Yes	BlendTrans Slope (%)	3.1
No	Ramp Width (in)	40.5	No	BlendTrans XSlope (%)	4.3
N/A	Flare Type LT	N/A	N/A	Flare Type RT	N/A
N/A	Flare Slope LT (%)	N/A	N/A	Flare Slope RT (%)	N/A
N/A	Flare Traversable LT?	N/A	N/A	Flare Traversable RT?	N/A
N/A	Landing Length (in)	N/A	N/A	DWS Provided?	N/A
N/A	Landing Width (in)	N/A	N/A	DWS Contrast?	N/A
N/A	Landing Slope (%)	N/A	N/A	DWS Length (in)	N/A
N/A	Landing X Slope (%)	N/A	N/A	DWS Full Width?	N/A
N/A	Landing Curb? (Y/N)	N/A	N/A	DWS Offset (in)	N/A
N/A	Shared Landing?	N/A			
N/A	Gutter Ponding?	N/A	N/A	Gutter Slope (%)	N/A
N/A	Gutter Lip Ht (in)	N/A	N/A	Gutter X Slope (%)	N/A
N/A	Painted X Walk1?	No	N/A	Painted X Walk2?	No
	X Walk 1 Direction	To SE		X Walk 2 Direction	To NE
	X Walk 1 Width (in)	N/A		X Walk 2 Width (in)	N/A
	X Walk 1 Slope (%)	2.5		X Walk 2 Slope (%)	7.1
	X Walk 1 X Slope (%)	5.2		X Walk 2 X Slope (%)	1.1

N/A	Ramp inside XWalk1?	N/A	N/A	Ramp inside XWalk2?	N/A
	Road Slope (%)	4.5		Clear Space?	N/A
	Road X Slope (%)	3.3	N/A	Clear Space to XWalk (in)	N/A
N/A	Any Obstructions?	N/A	N/A	Storm Grate/Utility Hazard?	N/A
	Obstruction Type			Storm Grate/Utility Type	
		N/A			N/A
			Yes	Surface Condition? (G/P)	Good
			No	Curb Slope (%)	9.5

Remove & Replace Curb Ramp With Two New Directional Ramps or Equivalent.
