Access Compliance Report

Public Rights-of-Way

(Curb Ramps)

Intersection ID: 4324	Main Street: LAKEVIEW_RD	Cross Street: POTOMAC_BV	Location: NE
ADA ID: 3BC0CA16A034	Ramp Type: Directional1	Initial Pass/Fail: Pass	Overall Compliance: No
Severity Score: 0			
Codes/Mitigation Info/Possible Solution		Field Measurements/Component Compliance

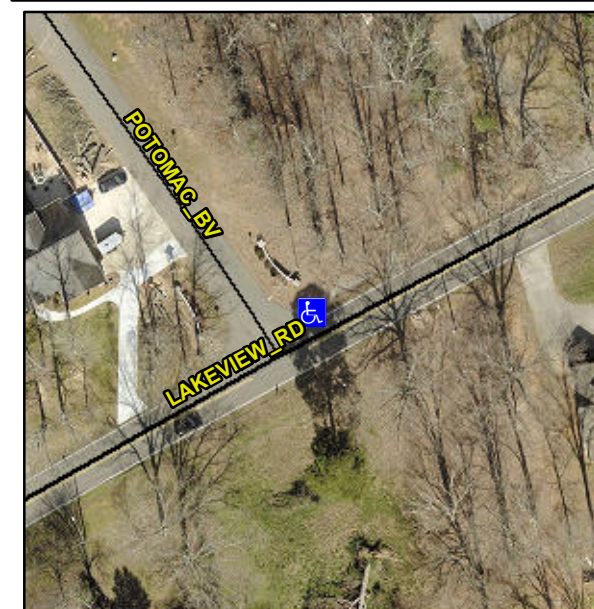
Compliance	Description	Data	Compliance	Description	Data
N/A	Ramp Length (in)	59.5	Yes	Grade Break?	Yes
Yes	Ramp Width (in)	60.0	Yes	Grade Break Slope (%)	2.3
Yes	Ramp Slope (%)	2.7	No	Grade Break XSlope (%)	2.4
Yes	Ramp XSlope (%)	0.5			
N/A	Flare Type LT	N/A	N/A	Flare Type RT	N/A
N/A	Flare Slope LT (%)	N/A	N/A	Flare Slope RT (%)	N/A
N/A	Flare Traversable LT?	N/A	N/A	Flare Traversable RT?	N/A
Yes	Landing Length (in)	60.0	Yes	DWS Provided?	Yes
Yes	Landing Width (in)	60.0	Yes	DWS Contrast?	Yes
No	Landing Slope (%)	3.3	Yes	DWS Length (in)	24.0
Yes	Landing X Slope (%)	0.4	Yes	DWS Full Width?	Yes
N/A	Landing Curb? (Y/N)	No	No	DWS Offset LT (in)	74.0
N/A	Shared Landing?	No	No	DWS Offset RT (in)	4.0
Yes	Gutter Ponding?	No	Yes	Gutter Slope (%)	1.1
Yes	Gutter Lip Ht (in)	0.0	No	Gutter X Slope (%)	3.6
N/A	Painted X Walk1?	No		Road Slope (%)	1.8
	X Walk 1 Direction	To W		Road X Slope (%)	1.8
	X Walk 1 Width (in)	N/A		Clear Space?	Yes

X Walk 1 Slope (%)	1.8	N/A	Clear Space to XWalk (in)	N/A
	X Walk 1 X Slope (%)	1.8	Yes	Storm Grate/Utility Hazard?	No
N/A	Ramp inside XWalk1?	N/A		Storm Grate/Utility Type	
Yes	Any Obstructions?	No			N/A
	Obstruction Type		Yes	Surface Condition? (G/P)	Good
			N/A	Curb Slope (%)	1.0

Possible Solutions:

**Remove & Replace Entire Ramp.
Remove & Replace Gutter.**
