Intersection ID: 31883	Main Street: CENTERLINE_DR	Cross Street: SPRUCE_PEAK_RD	Location:	SW
ADA ID: 3BC3D074093C	Ramp Type: PerpDiag	Initial Pass/Fail: Fail	Overall Compliance: No	Severity Score: 21.25

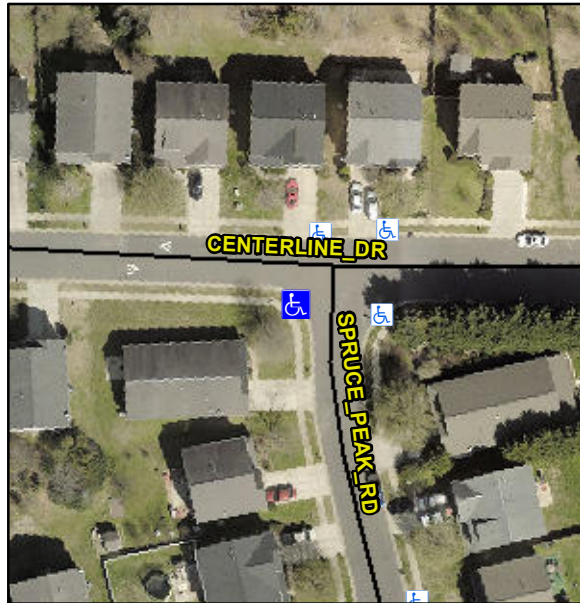
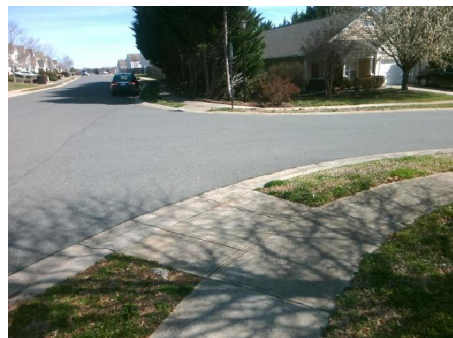
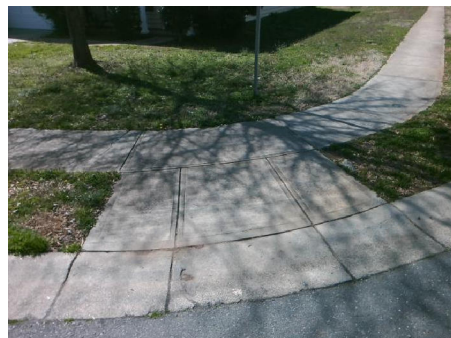
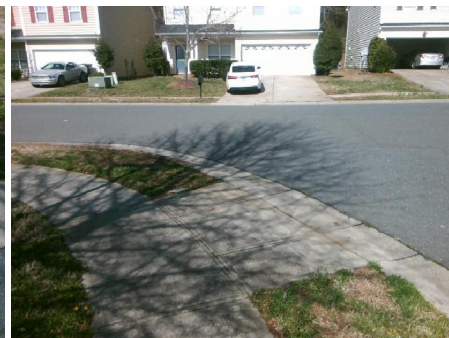
R304.5.1, R304.5.3

Compliance	Description	Data	Compliance	Description	Data
N/A	Ramp Length (in)	50.0	Yes	Ramp Slope (%)	5.2
No	Ramp Width (in)	38.5	No	Ramp XSlope (%)	5.8
N/A	Flare Type LT	N/A	N/A	Flare Type RT	N/A
N/A	Flare Slope LT (%)	N/A	N/A	Flare Slope RT (%)	N/A
N/A	Flare Traversable LT?	N/A	N/A	Flare Traversable RT?	N/A
N/A	Landing Length (in)	N/A	N/A	DWS Provided?	N/A
N/A	Landing Width (in)	N/A	N/A	DWS Contrast?	N/A
N/A	Landing Slope (%)	N/A	N/A	DWS Length (in)	N/A
N/A	Landing X Slope (%)	N/A	N/A	DWS Full Width?	N/A
N/A	Landing Curb? (Y/N)	N/A	N/A	DWS Offset (in)	N/A
N/A	Shared Landing?	N/A			
N/A	Gutter Ponding?	N/A	N/A	Gutter Slope (%)	N/A
N/A	Gutter Lip Ht (in)	N/A	N/A	Gutter X Slope (%)	N/A
N/A	Painted X Walk1?	No	N/A	Painted X Walk2?	No
	X Walk 1 Direction	To SE		X Walk 2 Direction	To NE
N/A	X Walk 1 Width (in)	N/A	N/A	X Walk 2 Width (in)	N/A
	X Walk 1 Slope (%)	4.7		X Walk 2 Slope (%)	9.8
	X Walk 1 X Slope (%)	3.9		X Walk 2 X Slope (%)	1.8

N/A	Ramp inside XWalk1?	N/A	N/A	Ramp inside XWalk2?	N/A
	Road Slope (%)	3.7	N/A	Clear Space?	N/A
	Road X Slope (%)	7.0	N/A	Clear Space to XWalk (in)	N/A
N/A	Any Obstructions?	N/A	N/A	Storm Grate/Utility Hazard?	N/A
	Obstruction Type			Storm Grate/Utility Type	
		N/A			N/A
			Yes	Surface Condition? (G/P)	Good

Remove & Replace Curb Ramp With Two New Directional Ramps or Equivalent.
