Access Compliance Report

Public Rights-of-Way

(Curb Ramps)

Intersection ID: 26975	Main Street: SOUTH_HALL_DR	Cross Street: WARWICKSHIRE_LN	Location: N
ADA ID: 3BD3C3318FDC	Ramp Type: PerpDiag	Initial Pass/Fail: Fail	Overall Compliance: No
			Severity Score: 33.75

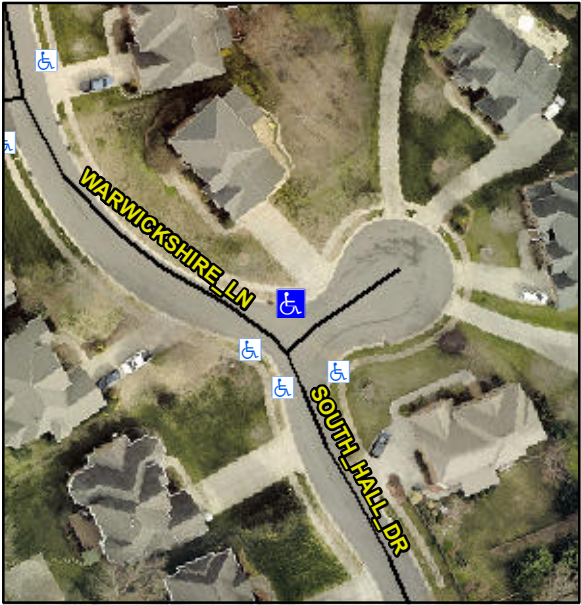
Possible Solutions:		Compliance	Description	Data
	Remove & Replace Curb Ramp With Two New Directional Ramps or Equivalent.		Yes	Ramp Length (in)	46.5
			No	Ramp Width (in)	45.5
			N/A	Flare Type LT	N/A
			N/A	Flare Slope LT (%)	N/A
			N/A	Flare Traversable LT?	N/A
			N/A	Landing Length (in)	N/A
			N/A	Landing Width (in)	N/A
			N/A	Landing Slope (%)	N/A
			N/A	Landing X Slope (%)	N/A
<p>Surveyor Notes:</p> <p>N/A</p> <p>PROW/ADA:</p> <p>Not Found, R304.5.1, R304.5.3</p>			N/A	Flare Type RT	N/A
			N/A	Flare Slope RT (%)	N/A
			N/A	Flare Traversable RT?	N/A
			N/A	DWS Provided?	N/A
			N/A	DWS Contrast?	N/A
			N/A	DWS Length (in)	N/A
			N/A	DWS Full Width?	N/A
			N/A	DWS Offset (in)	N/A
			N/A	Gutter Ponding?	N/A
			N/A	Gutter Lip Ht (in)	N/A
			No	Painted X Walk1?	N/A
			No	Painted X Walk2?	N/A
			To SW	X Walk 2 Direction	To S
			N/A	X Walk 2 Width (in)	N/A

2.9	X Walk 2 Slope (%)	6.4
			5.2	X Walk 2 X Slope (%)	3.3
			N/A	Ramp inside XWalk2?	N/A
			N/A	Clear Space?	N/A
			6.8	Clear Space to XWalk (in)	N/A
			N/A	Storm Grate/Utility Hazard?	N/A
			N/A	Storm Grate/Utility Type	N/A
			N/A	Surface Condition? (G/P)	Good
Total Cost:		\$ 3200.00
