Access Compliance Report

Public Rights-of-Way

(Curb Ramps)

Intersection ID: 10015568	Main Street: CARMINE_ST	Cross Street: N/A	Location: NW
ADA ID: 3BD722E886C8	Ramp Type: Perp	Initial Pass/Fail: Fail	Overall Compliance: No
Severity Score: 46.25			
Codes/Mitigation Info/Possible Solution		Field Measurements/Component Compliance

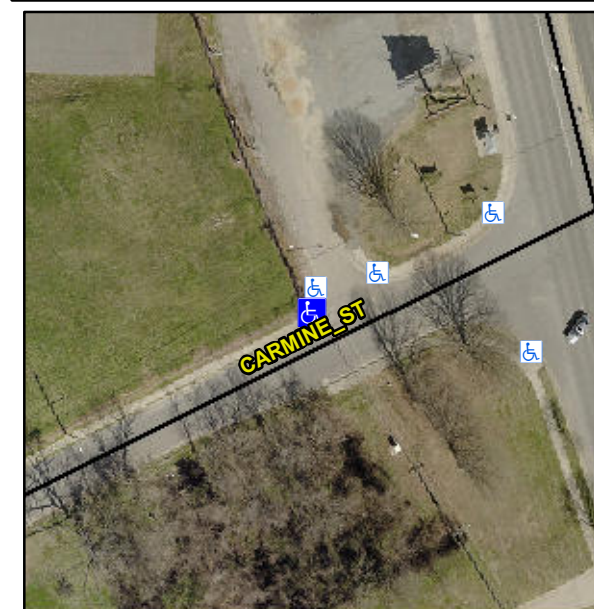
Not Found, R304.5.1, R304.2.2, R304.5.3

Compliance	Description	Data	Compliance	Description	Data
N/A	Ramp Length (in)	60.0	No	Ramp Slope (%)	11.9
No	Ramp Width (in)	37.0	No	Ramp XSlope (%)	7.2
N/A	Flare Type LT	N/A	N/A	Flare Type RT	N/A
N/A	Flare Slope LT (%)	N/A	N/A	Flare Slope RT (%)	N/A
N/A	Flare Traversable LT?	N/A	N/A	Flare Traversable RT?	N/A
N/A	Landing Length (in)	N/A	N/A	DWS Provided?	N/A
N/A	Landing Width (in)	N/A	N/A	DWS Contrast?	N/A
N/A	Landing Slope (%)	N/A	N/A	DWS Length (in)	N/A
N/A	Landing X Slope (%)	N/A	N/A	DWS Full Width?	N/A
N/A	Landing Curb? (Y/N)	N/A	N/A	DWS Offset (in)	N/A
N/A	Shared Landing?	N/A			
N/A	Gutter Ponding?	N/A	N/A	Gutter Slope (%)	N/A
N/A	Gutter Lip Ht (in)	N/A	N/A	Gutter X Slope (%)	N/A
N/A	Painted X Walk1?	No	N/A	Painted X Walk2?	N/A
	X Walk 1 Direction	To S		X Walk 2 Direction	N/A
N/A	X Walk 1 Width (in)	N/A	N/A	X Walk 2 Width (in)	N/A
	X Walk 1 Slope (%)	1.8		X Walk 2 Slope (%)	N/A
	X Walk 1 X Slope (%)	4.6		X Walk 2 X Slope (%)	N/A

Remove & Replace Entire Ramp.
