# Access Compliance Report

## Public Rights-of-Way (Curb Ramps)

Intersection ID: 31190	Main Street: CROFT_HAVEN_DR	Cross Street: DAVIS_RIDGE_DR	Location: SE
ADA ID: 3BD77FD8496B	Ramp Type: PerpDiag	Initial Pass/Fail: Fail	Overall Compliance: No
Severity Score: 8.75			
Codes/Mitigation Info/Possible Solution		Field Measurements/Component Compliance

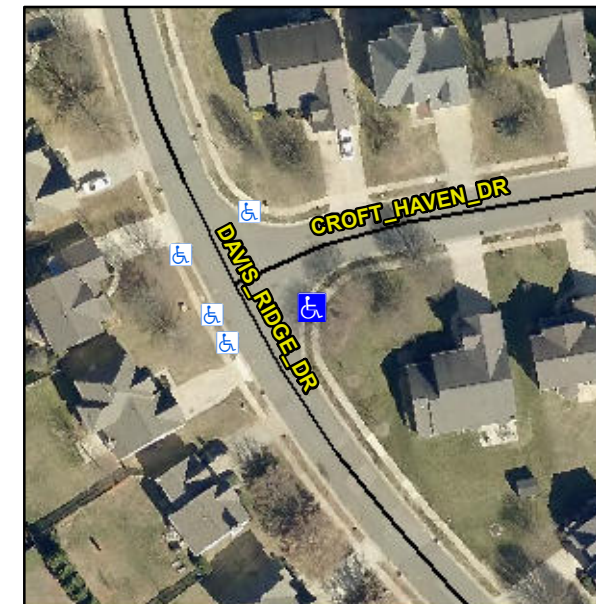
**Not Found, R304.5.1**

Compliance	Description	Data	Compliance	Description	Data
N/A	Ramp Length (in)	48.0	Yes	Ramp Slope (%)	5.5
No	Ramp Width (in)	47.5	Yes	Ramp XSlope (%)	0.2
N/A	Flare Type LT	N/A	N/A	Flare Type RT	N/A
N/A	Flare Slope LT (%)	N/A	N/A	Flare Slope RT (%)	N/A
N/A	Flare Traversable LT?	N/A	N/A	Flare Traversable RT?	N/A
N/A	Landing Length (in)	N/A	N/A	DWS Provided?	N/A
N/A	Landing Width (in)	N/A	N/A	DWS Contrast?	N/A
N/A	Landing Slope (%)	N/A	N/A	DWS Length (in)	N/A
N/A	Landing X Slope (%)	N/A	N/A	DWS Full Width?	N/A
N/A	Landing Curb? (Y/N)	N/A	N/A	DWS Offset (in)	N/A
N/A	Shared Landing?	N/A			
N/A	Gutter Ponding?	N/A	N/A	Gutter Slope (%)	N/A
N/A	Gutter Lip Ht (in)	N/A	N/A	Gutter X Slope (%)	N/A
N/A	Painted X Walk1?	No	N/A	Painted X Walk2?	No
	X Walk 1 Direction	To N		X Walk 2 Direction	To W
N/A	X Walk 1 Width (in)	N/A	N/A	X Walk 2 Width (in)	N/A
	X Walk 1 Slope (%)	6.1		X Walk 2 Slope (%)	3.8
	X Walk 1 X Slope (%)	0.8		X Walk 2 X Slope (%)	6.5

N/A	Ramp inside XWalk1?	N/A	N/A	Ramp inside XWalk2?	N/A
	Road Slope (%)	1.2	N/A	Clear Space?	N/A
	Road X Slope (%)	7.3	N/A	Clear Space to XWalk (in)	N/A
N/A	Any Obstructions?	N/A	N/A	Storm Grate/Utility Hazard?	N/A
	Obstruction Type			Storm Grate/Utility Type	
		N/A			N/A
			Yes	Surface Condition? (G/P)	Good

**Remove & Replace Curb Ramp With Two New Directional Ramps or Equivalent.**

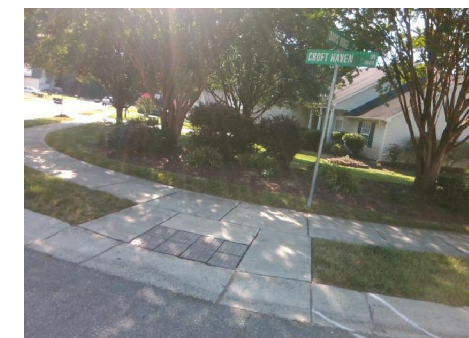
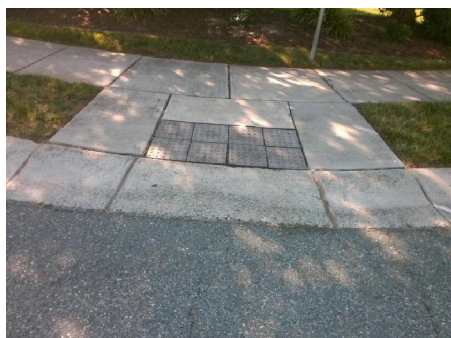
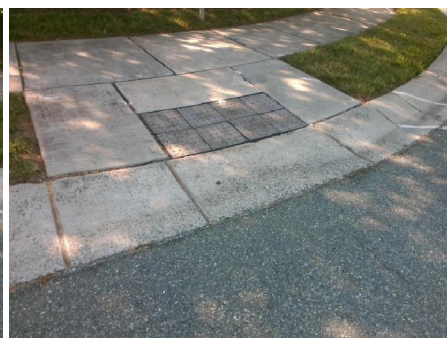
Street 1 Name CROFT HAVEN DR  
Stop Condition-Street 2 StopSign  
Street 2 Name DAVIS RIDGE DR  
Stop Condition-Street 1 None
