Access Compliance Report Public Rights-of-Way (Curb Ramps)

-							
Intersection ID: 47753	Main Str	Main Street: ARBOR_CREEK_DR		Cross Street: REBECCA_RUN_DR				Location:	S
ADA ID: 3BDBC79FEE55	Ramp Ty	Ramp Type: PerpDiag		Initial Pass/Fail: Fail Overall Compliance: No				o Severity Score:	37.5
Codes/Mitigation Info/Possible Solution				Field Measurements/Component Compliance					
		Possible Solutions:		Compliance Description			Data Compliance Description		
		Remove & Replace Curb Ramp W Two New Directional Ramps or Equivalent.	amp With	N/A	Ramp Length (in)	47.0	No	Ramp Slope (%)	9.2

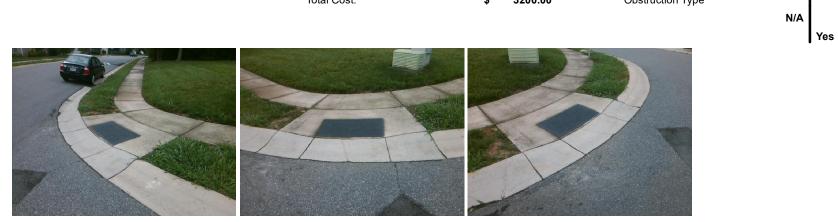
•	Yes	Ramp Width (in)	48.0	No	Ramp XSlope (%)	9.4
				N/A	Flare Type LT	N/A	N/A	Flare Type RT	N/A
				N/A	Flare Slope LT (%)	N/A	N/A	Flare Slope RT (%)	N/A
205				N/A	Flare Traversable LT?	N/A	N/A	Flare Traversable RT?	N/A
				N/A	Landing Length (in)	N/A	N/A	DWS Provided?	N/A
La Carte		Surveyor Notes:		N/A	Landing Width (in)	N/A	N/A	DWS Contrast?	N/A
		N/A		N/A	Landing Slope (%)	N/A	N/A	DWS Length (in)	N/A
PROW/ADA: Not Found, R304.2.2, R304.5.3				N/A	Landing X Slope (%)	N/A	N/A	DWS Full Width?	N/A
				N/A	Landing Curb? (Y/N)	N/A	N/A	DWS Offset (in)	N/A
				N/A	Shared Landing?	N/A			
				N/A	Gutter Ponding?	N/A	N/A	Gutter Slope (%)	N/A
	<u>E.</u>	Not Found, R304.2.2, R304	53	N/A	Gutter Lip Ht (in)	N/A	N/A	Gutter X Slope (%)	N/A
			.0.0	N/A	Painted X Walk1?	No	N/A	Painted X Walk2?	No
					X Walk 1 Direction	To NE		X Walk 2 Direction	To NW
			N/A	X Walk 1 Width (in)	N/A	N/A	X Walk 2 Width (in)	N/A	
Street 1 Name	ARBOR CREEK DR	-			X Walk 1 Slope (%)	1.0		X Walk 2 Slope (%)	0.6

Stop Condition-Street 2	None				X Walk 1 X Slope (%)	1.4		X Walk 2 X Slope (%)	7.1
Street 2 Name	REBECCA RUN DR			N/A	Ramp inside XWalk1?	N/A	N/A	Ramp inside XWalk2?	N/A
Stop Condition-Street 1	StopSign				Road Slope (%)	8.1	N/A	Clear Space?	N/A
	cicpoign				Road X Slope (%)	4.0	N/A	Clear Space to XWalk (in)	N/A
				N/A	Any Obstructions?	4.0 N/A		Storm Grate/Utility Hazard?	N/A
		Total Cost:	\$ 3200.00		Obstruction Type			Storm Grate/Utility Type	
1			+ 0200.00			N/A			N/A
						IN/A			11/1
