## Access Compliance Report Public Rights-of-Way (Curb Ramps)

Intersection ID: 29700
 Main Street:
 CAMERON\_CREEK\_DR
 Cross Street:
 WEDDINGTON\_RIDGE\_LN
 Location:
 W

ADA ID: 3BEBBC00324E
 Ramp Type:
 BlendTrans1
 Initial Pass/Fail:
 Fail
 Overall Compliance:
 No
 Severity Score:
 10

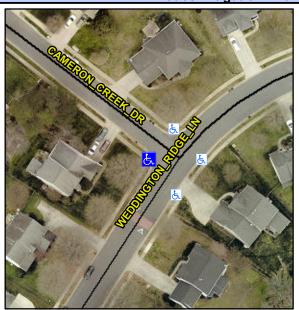
Compliance Description		Data	Compliance Description		Data
	N/A	Ramp Length (in)	48.0	Yes	BlendTrans Slope (%)	3.3
	No	Ramp Width (in)	36.0	No	BlendTrans XSlope (%)	2.1
	N/A	Flare Type LT	N/A	N/A	Flare Type RT	N/A
	N/A	Flare Slope LT (%)	N/A	N/A	Flare Slope RT (%)	N/A
	N/A	Flare Traversable LT?	N/A	N/A	Flare Traversable RT?	N/A
	N/A	Landing Length (in)	N/A	N/A	DWS Provided?	N/A
	N/A	Landing Width (in)	N/A	N/A	DWS Contrast?	N/A
	N/A	Landing Slope (%)	N/A	N/A	DWS Length (in)	N/A
	N/A	Landing X Slope (%)	N/A	N/A	DWS Full Width?	N/A
	N/A	Landing Curb? (Y/N)	N/A	N/A	DWS Offset (in)	N/A
	N/A	Shared Landing?	N/A			
	N/A	Gutter Ponding?	N/A	N/A	Gutter Slope (%)	N/A
	N/A	Gutter Lip Ht (in)	N/A	N/A	Gutter X Slope (%)	N/A
	N/A	Painted X Walk1?	No	N/A	Painted X Walk2?	No
		X Walk 1 Direction	To SE		X Walk 2 Direction	To NE
		X Walk 1 Width (in)	N/A		X Walk 2 Width (in)	N/A
		X Walk 1 Slope (%)	1.1		X Walk 2 Slope (%)	0.4

X Walk 1 X Slope (%)	0.0		X Walk 2 X Slope (%)	0.4
	N/A	Ramp inside XWalk1?	N/A	N/A	Ramp inside XWalk2?	N/A
		Road Slope (%)	0.8		Clear Space?	N/A
		Road X Slope (%)	0.3	N/A	Clear Space to XWalk (in)	N/A
	N/A	Any Obstructions?	N/A	N/A	Storm Grate/Utility Hazard?	N/A
		Obstruction Type			Storm Grate/Utility Type	
			N/A			N/A
				Yes	Surface Condition? (G/P)	Good
4	-			N/A	Curb Slope (%)	3.3

Remove & Replace Curb Ramp With
Two New Directional Ramps or
Equivalent.

PROW/ADA:
R304.5.1, R304.5.3
