Access Compliance Report Public Rights-of-Way (Curb Ramps)

Intersection ID: 10025869 Main Street: ELEVATION POINT DR **Cross Street: N/A** Location: NE **Overall Compliance: No** ADA ID: 3BF7AE417729 Ramp Type: Perp Initial Pass/Fail: Fail **Severity Score:** 12.5

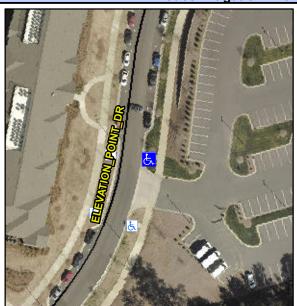
Comp	oliance Description	Data	Comp	liance	Description	Data
N/A	Ramp Length (in)	105.0	No	Ram	Slope (%)	8.6
Yes	Ramp Width (in)	59.5	Yes	Ram	XSlope (%)	0.8
N/A	Flare Type LT	N/A	N/A	Flare	Type RT	N/A
N/A	Flare Slope LT (%)	N/A	N/A	Flare	Slope RT (%)	N/A
N/A	Flare Traversable LT?	N/A	N/A	Flare	Traversable RT?	N/A
N/A	Landing Length (in)	N/A	N/A	DWS	Provided?	N/A
N/A	Landing Width (in)	N/A	N/A	DWS	N/A	
N/A	Landing Slope (%)	N/A	N/A	DWS	Length (in)	N/A
N/A	Landing X Slope (%)	N/A	N/A	DWS Full Width?		N/A
N/A	Landing Curb? (Y/N)	N/A	N/A	DWS	Offset (in)	N/A
N/A	Shared Landing?	N/A				
N/A	Gutter Ponding?	N/A	N/A	Gutte	r Slope (%)	N/A
N/A	Gutter Lip Ht (in)	N/A	N/A	Gutte	r X Slope (%)	N/A
N/A	Painted X Walk1?	No	N/A	Paint	ed X Walk2?	N/A
	X Walk 1 Direction	To W		X Wa	lk 2 Direction	N/A
N/A	X Walk 1 Width (in)	N/A	N/A	X Wa	lk 2 Width (in)	N/A
	X Walk 1 Slope (%)	2.4		X Wa	lk 2 Slope (%)	N/A
	X Walk 1 X Slope (%)	3.1		X Wa	lk 2 X Slope (%)	N/A

N/A	Ramp inside XWalk1?	N/A	N/A	Ramı	inside XWalk2?	N/A
	Road Slope (%)	N/A	N/A	Clear	Space?	N/A
	Road X Slope (%)	N/A	N/A	Clear	Space to XWalk (in)	N/A
N/A	Any Obstructions?	N/A	N/A	Storn	n Grate/Utility Hazard?	N/A
	Obstruction Type			Storn	n Grate/Utility Type	
		N/A				N/A
			Yes	Surfa	ce Condition? (G/P)	Good
. 34			-

Possible Solutions:	Compli	ance	Description
Remove & Replace Entire Ramp.	N/A	Ramp Length (in)	
·	Yes	Ramp	Width (in)
	N/A	Flare	Type LT
	N/A	Flare Slope LT (%) Flare Traversable LT	
	N/A		
	N/A	Landi	ng Length (in)
Surveyor Notes:	N/A	Landi	ng Width (in)
N/A	N/A	Landing Slope (%)	
	N/A	Landi	ng X Slope (%
	N/A	Landi	ng Curb? (Y/N
	N/A	Share	ed Landing?
PROW/ADA:	N/A	Gutte	r Ponding?
Not Found, R304.2.2	N/A	Gutter Lip Ht (in)	
	N/A	Painte	ed X Walk1?
		X Wa	lk 1 Direction
	N/A	X Wa	lk 1 Width (in)
		X Wa	lk 1 Slope (%)
		X Wa	lk 1 X Slope (%
	N/A	Ramp	inside XWalk
