Access Compliance Report

Public Rights-of-Way

(Curb Ramps)

Intersection ID: 14213	Main Street: CENTRAL_AV	Cross Street: ROSEHAVEN_DR	Location: SW
ADA ID: 3BFCA5398980	Ramp Type: BlendTrans1	Initial Pass/Fail: Fail	Overall Compliance: No
		Severity Score: 10

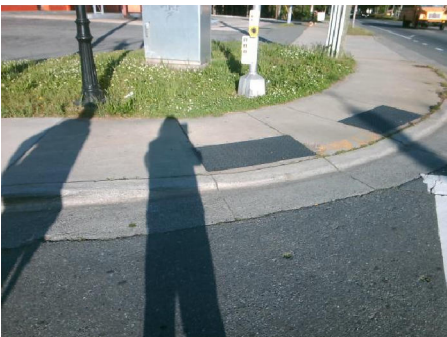
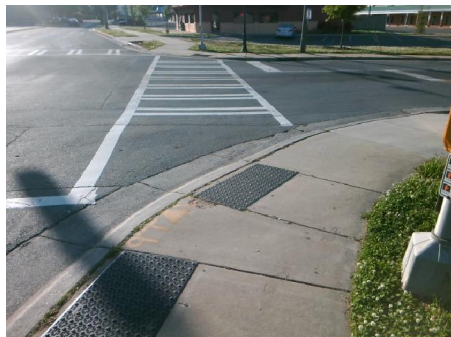
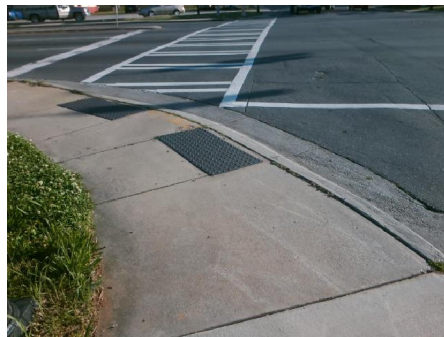
Compliance	Description	Data	Compliance	Description	Data
N/A	Ramp Length (in)	71.5	Yes	BlendTrans Slope (%)	3.3
No	Ramp Width (in)	39.5	Yes	BlendTrans XSlope (%)	4.1
N/A	Flare Type LT	N/A	N/A	Flare Type RT	N/A
N/A	Flare Slope LT (%)	N/A	N/A	Flare Slope RT (%)	N/A
N/A	Flare Traversable LT?	N/A	N/A	Flare Traversable RT?	N/A
N/A	Landing Length (in)	N/A	N/A	DWS Provided?	N/A
N/A	Landing Width (in)	N/A	N/A	DWS Contrast?	N/A
N/A	Landing Slope (%)	N/A	N/A	DWS Length (in)	N/A
N/A	Landing X Slope (%)	N/A	N/A	DWS Full Width?	N/A
N/A	Landing Curb? (Y/N)	N/A	N/A	DWS Offset (in)	N/A
N/A	Shared Landing?	N/A			
N/A	Gutter Ponding?	N/A	N/A	Gutter Slope (%)	N/A
N/A	Gutter Lip Ht (in)	N/A	N/A	Gutter X Slope (%)	N/A
N/A	Painted X Walk1?	Yes	N/A	Painted X Walk2?	N/A
	X Walk 1 Direction	To SE		X Walk 2 Direction	N/A
	X Walk 1 Width (in)	108.0		X Walk 2 Width (in)	N/A
	X Walk 1 Slope (%)	1.1		X Walk 2 Slope (%)	N/A
	X Walk 1 X Slope (%)	4.2		X Walk 2 X Slope (%)	N/A

N/A	Ramp inside XWalk1?	Yes	N/A	Ramp inside XWalk2?	N/A
	Road Slope (%)	4.2		Clear Space?	N/A
	Road X Slope (%)	1.1	N/A	Clear Space to XWalk (in)	N/A
N/A	Any Obstructions?	N/A	N/A	Storm Grate/Utility Hazard?	N/A
	Obstruction Type			Storm Grate/Utility Type	
		N/A			N/A
			Yes	Surface Condition? (G/P)	Good
			No	Curb Slope (%)	26.4

Possible Solutions:

Remove & Replace Curb Ramp With Two New Directional Ramps or Equivalent.
