Access Compliance Report Public Rights-of-Way (Curb Ramps)

Intersection ID: 53286 Main Street: PROSPERITY_CHURCH_RD Cross Street: CRAVEN_THOMAS_RD Location: E

ADA ID: 3BFF3A5C5CE6 Ramp Type: Perp Initial Pass/Fail: Fail Overall Compliance: No Severity Score: 25

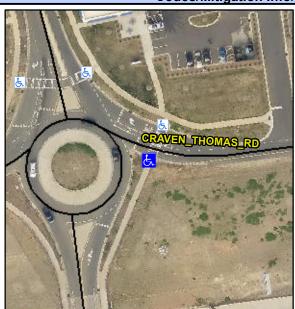
R304.2.2

Field Measurements/Component Compliance						
Compliance Description			Data	Compliance Description		Data
1	N/A	Ramp Length (in)	100.0	No	Ramp Slope (%)	15.1
١	es/	Ramp Width (in)	48.0	Yes	Ramp XSlope (%)	1.9
N	N/A	Flare Type LT	N/A	N/A	Flare Type RT	N/A
1	N/A	Flare Slope LT (%)	N/A	N/A	Flare Slope RT (%)	N/A
1	N/A	Flare Traversable LT?	N/A	N/A	Flare Traversable RT?	N/A
1	N/A	Landing Length (in)	N/A	N/A	DWS Provided?	N/A
1	N/A	Landing Width (in)	N/A	N/A	DWS Contrast?	N/A
1	N/A	Landing Slope (%)	N/A	N/A	DWS Length (in)	N/A
1	N/A	Landing X Slope (%)	N/A	N/A	DWS Full Width?	N/A
ı	N/A	Landing Curb? (Y/N)	N/A	N/A	DWS Offset (in)	N/A
ı	N/A	Shared Landing?	N/A			
ı	N/A	Gutter Ponding?	N/A	N/A	Gutter Slope (%)	N/A
N	N/A	Gutter Lip Ht (in)	N/A	N/A	Gutter X Slope (%)	N/A
ı	N/A	Painted X Walk1?	Yes	N/A	Painted X Walk2?	N/A
		X Walk 1 Direction	To N		X Walk 2 Direction	N/A
ı	N/A	X Walk 1 Width (in)	105.0	N/A	X Walk 2 Width (in)	N/A

X Walk 1 Slope (%)	2.2		X Walk 2 Slope (%)	N/A
		X Walk 1 X Slope (%)	0.5		X Walk 2 X Slope (%)	N/A
ı	N/A	Ramp inside XWalk1?	Yes	N/A	Ramp inside XWalk2?	N/A
		Road Slope (%)	N/A	N/A	Clear Space?	N/A
		Road X Slope (%)	N/A	N/A	Clear Space to XWalk (in)	N/A
ı	N/A	Any Obstructions?	N/A	N/A	Storm Grate/Utility Hazard?	N/A
		Obstruction Type			Storm Grate/Utility Type	
			N/A			N/A
				Yes	Surface Condition? (G/P)	Good

Possible Solutions:

Remove & Replace Entire Ramp.

Total Cost: \$ 1850.00
