Access Compliance Report

Public Rights-of-Way

(Curb Ramps)

Intersection ID: 26115	Main Street: CARMEL_CHACE_DR	Cross Street: CARMEL_RD	Location: NE
ADA ID: 3BFF8896BE18	Ramp Type: PerpDiag	Initial Pass/Fail: Fail	Overall Compliance: No
Severity Score: 13.75			
Codes/Mitigation Info/Possible Solution		Field Measurements/Component Compliance

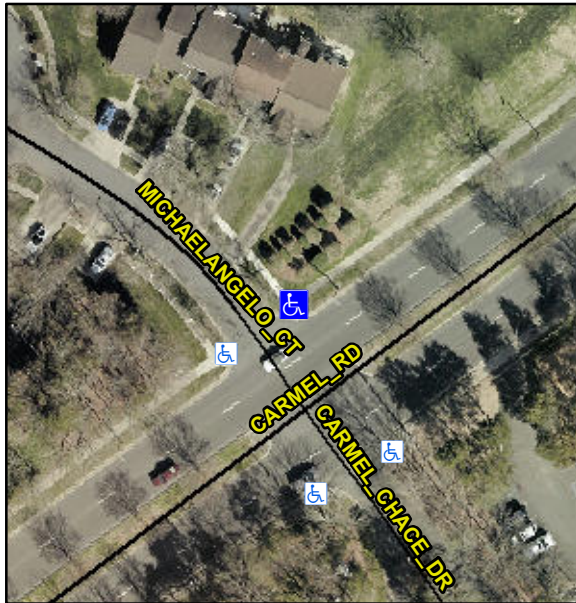
Compliance	Description	Data	Compliance	Description	Data
N/A	Ramp Length (in)	96.0	No	Ramp Slope (%)	8.9
Yes	Ramp Width (in)	48.0	No	Ramp XSlope (%)	4.9
N/A	Flare Type LT	N/A	N/A	Flare Type RT	N/A
N/A	Flare Slope LT (%)	N/A	N/A	Flare Slope RT (%)	N/A
N/A	Flare Traversable LT?	N/A	N/A	Flare Traversable RT?	N/A
N/A	Landing Length (in)	N/A	N/A	DWS Provided?	N/A
N/A	Landing Width (in)	N/A	N/A	DWS Contrast?	N/A
N/A	Landing Slope (%)	N/A	N/A	DWS Length (in)	N/A
N/A	Landing X Slope (%)	N/A	N/A	DWS Full Width?	N/A
N/A	Landing Curb? (Y/N)	N/A	N/A	DWS Offset (in)	N/A
N/A	Shared Landing?	N/A			
N/A	Gutter Ponding?	N/A	N/A	Gutter Slope (%)	N/A
N/A	Gutter Lip Ht (in)	N/A	N/A	Gutter X Slope (%)	N/A
N/A	Painted X Walk1?	No	N/A	Painted X Walk2?	No
	X Walk 1 Direction	To W		X Walk 2 Direction	To S
N/A	X Walk 1 Width (in)	N/A	N/A	X Walk 2 Width (in)	N/A
	X Walk 1 Slope (%)	2.2		X Walk 2 Slope (%)	3.8
	X Walk 1 X Slope (%)	1.7		X Walk 2 X Slope (%)	3.1

N/A	Ramp inside XWalk1?	N/A	N/A	Ramp inside XWalk2?	N/A
	Road Slope (%)	3.3	N/A	Clear Space?	N/A
	Road X Slope (%)	9.2	N/A	Clear Space to XWalk (in)	N/A
N/A	Any Obstructions?	N/A	N/A	Storm Grate/Utility Hazard?	N/A
	Obstruction Type			Storm Grate/Utility Type	
		N/A			N/A
			Yes	Surface Condition? (G/P)	Good

Possible Solutions:

Remove & Replace Curb Ramp With Two New Directional Ramps or Equivalent.
