Access Compliance Report

Public Rights-of-Way (Curb Ramps)

Intersection ID: 45776	Main Street: CRABAPPLE_TREE_LN	Cross Street: CARVER_FALLS_RD	Location:	N
ADA ID: 3C105B42291E	Ramp Type: PerpDiag	Initial Pass/Fail: Fail	Overall Compliance: No	Severity Score: 13.75
Codes/Mitigation Info/Possible Solution		Field Measurements/Component Compliance

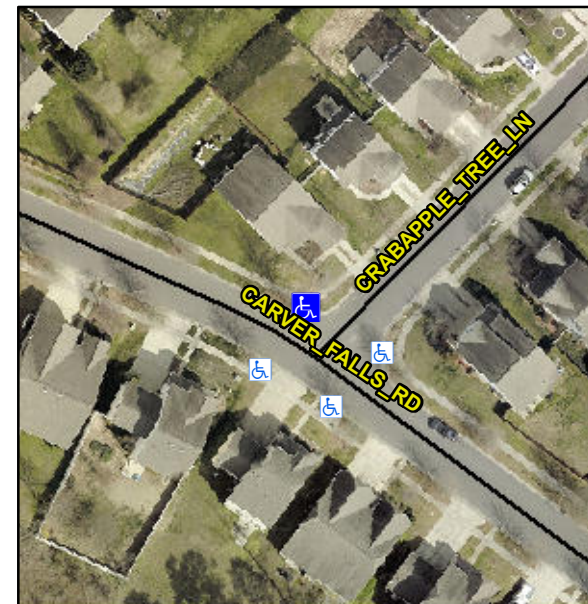
Compliance	Description	Data	Compliance	Description	Data
N/A	Ramp Length (in)	71.0	No	Ramp Slope (%)	8.7
Yes	Ramp Width (in)	48.0	No	Ramp XSlope (%)	2.3
N/A	Flare Type LT	N/A	N/A	Flare Type RT	N/A
N/A	Flare Slope LT (%)	N/A	N/A	Flare Slope RT (%)	N/A
N/A	Flare Traversable LT?	N/A	N/A	Flare Traversable RT?	N/A
N/A	Landing Length (in)	N/A	N/A	DWS Provided?	N/A
N/A	Landing Width (in)	N/A	N/A	DWS Contrast?	N/A
N/A	Landing Slope (%)	N/A	N/A	DWS Length (in)	N/A
N/A	Landing X Slope (%)	N/A	N/A	DWS Full Width?	N/A
N/A	Landing Curb? (Y/N)	N/A	N/A	DWS Offset (in)	N/A
N/A	Shared Landing?	N/A			
N/A	Gutter Ponding?	N/A	N/A	Gutter Slope (%)	N/A
N/A	Gutter Lip Ht (in)	N/A	N/A	Gutter X Slope (%)	N/A
N/A	Painted X Walk1?	No	N/A	Painted X Walk2?	No
	X Walk 1 Direction	To SW		X Walk 2 Direction	To SE
N/A	X Walk 1 Width (in)	N/A	N/A	X Walk 2 Width (in)	N/A
	X Walk 1 Slope (%)	1.5		X Walk 2 Slope (%)	0.2
	X Walk 1 X Slope (%)	0.7		X Walk 2 X Slope (%)	1.8

N/A	Ramp inside XWalk1?	N/A	N/A	Ramp inside XWalk2?	N/A
	Road Slope (%)	1.1	N/A	Clear Space?	N/A
	Road X Slope (%)	0.7	N/A	Clear Space to XWalk (in)	N/A
N/A	Any Obstructions?	N/A	N/A	Storm Grate/Utility Hazard?	N/A
	Obstruction Type			Storm Grate/Utility Type	
		N/A			N/A
			Yes	Surface Condition? (G/P)	Good

Remove & Replace Curb Ramp With Two New Directional Ramps or Equivalent.
