Access Compliance Report

Public Rights-of-Way

(Curb Ramps)

Intersection ID: 27763	Main Street: BALLANTYNE_CROSSING_AV	Cross Street: BRICK_CHURCH_CT	Location: SW
ADA ID: 3C2471F7427D	Ramp Type: PerpDiag	Initial Pass/Fail: Fail	Overall Compliance: No
Severity Score: 8.75			
Codes/Mitigation Info/Possible Solution		Field Measurements/Component Compliance

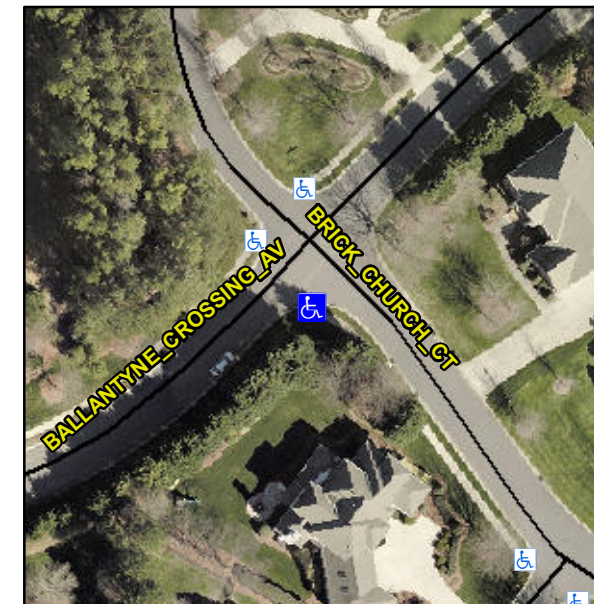
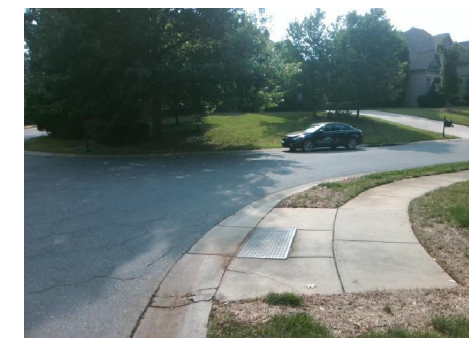
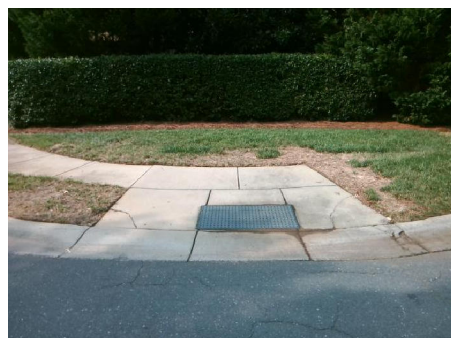
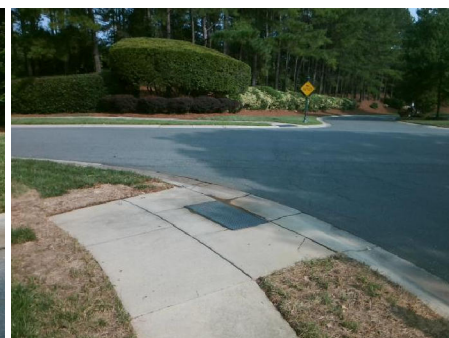
Compliance	Description	Data	Compliance	Description	Data
N/A	Ramp Length (in)	50.0	Yes	Ramp Slope (%)	6.1
No	Ramp Width (in)	41.0	Yes	Ramp XSlope (%)	0.9
N/A	Flare Type LT	N/A	N/A	Flare Type RT	N/A
N/A	Flare Slope LT (%)	N/A	N/A	Flare Slope RT (%)	N/A
N/A	Flare Traversable LT?	N/A	N/A	Flare Traversable RT?	N/A
N/A	Landing Length (in)	N/A	N/A	DWS Provided?	N/A
N/A	Landing Width (in)	N/A	N/A	DWS Contrast?	N/A
N/A	Landing Slope (%)	N/A	N/A	DWS Length (in)	N/A
N/A	Landing X Slope (%)	N/A	N/A	DWS Full Width?	N/A
N/A	Landing Curb? (Y/N)	N/A	N/A	DWS Offset (in)	N/A
N/A	Shared Landing?	N/A			
N/A	Gutter Ponding?	N/A	N/A	Gutter Slope (%)	N/A
N/A	Gutter Lip Ht (in)	N/A	N/A	Gutter X Slope (%)	N/A
N/A	Painted X Walk1?	No	N/A	Painted X Walk2?	No
	X Walk 1 Direction	To NE		X Walk 2 Direction	To NW
N/A	X Walk 1 Width (in)	N/A	N/A	X Walk 2 Width (in)	N/A
	X Walk 1 Slope (%)	1.8		X Walk 2 Slope (%)	3.1
	X Walk 1 X Slope (%)	1.9		X Walk 2 X Slope (%)	2.1

N/A	Ramp inside XWalk1?	N/A	N/A	Ramp inside XWalk2?	N/A
	Road Slope (%)	0.3	N/A	Clear Space?	N/A
	Road X Slope (%)	2.2	N/A	Clear Space to XWalk (in)	N/A
N/A	Any Obstructions?	N/A	N/A	Storm Grate/Utility Hazard?	N/A
	Obstruction Type			Storm Grate/Utility Type	
		N/A			N/A
			Yes	Surface Condition? (G/P)	Good

Remove & Replace Curb Ramp With Two New Directional Ramps or Equivalent.
