Access Compliance Report

Public Rights-of-Way

(Curb Ramps)

Intersection ID: 43644	Main Street: CEDAR_CROSSINGS_DR	Cross Street: KENDRICK_CROSS_RD	Location: SE
ADA ID: 3C2E246418E4	Ramp Type: PerpDiag	Initial Pass/Fail: Fail	Overall Compliance: No
Codes/Mitigation Info/Possible Solution		Field Measurements/Component Compliance	
Severity Score: 33.75

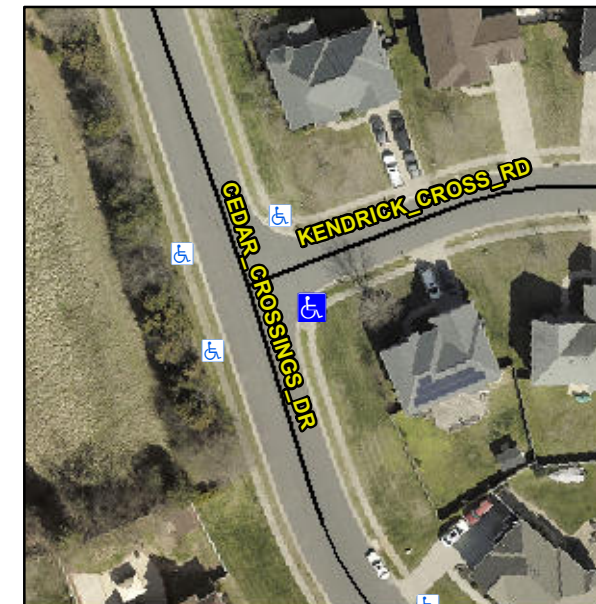
Compliance	Description	Data	Compliance	Description	Data
N/A	Ramp Length (in)	44.0	No	Ramp Slope (%)	12.3
No	Ramp Width (in)	47.0	Yes	Ramp XSlope (%)	1.1
N/A	Flare Type LT	N/A	N/A	Flare Type RT	N/A
N/A	Flare Slope LT (%)	N/A	N/A	Flare Slope RT (%)	N/A
N/A	Flare Traversable LT?	N/A	N/A	Flare Traversable RT?	N/A
N/A	Landing Length (in)	N/A	N/A	DWS Provided?	N/A
N/A	Landing Width (in)	N/A	N/A	DWS Contrast?	N/A
N/A	Landing Slope (%)	N/A	N/A	DWS Length (in)	N/A
N/A	Landing X Slope (%)	N/A	N/A	DWS Full Width?	N/A
N/A	Landing Curb? (Y/N)	N/A	N/A	DWS Offset (in)	N/A
N/A	Shared Landing?	N/A			
N/A	Gutter Ponding?	N/A	N/A	Gutter Slope (%)	N/A
N/A	Gutter Lip Ht (in)	N/A	N/A	Gutter X Slope (%)	N/A
N/A	Painted X Walk1?	No	N/A	Painted X Walk2?	No
	X Walk 1 Direction	To N		X Walk 2 Direction	To W
N/A	X Walk 1 Width (in)	N/A	N/A	X Walk 2 Width (in)	N/A
	X Walk 1 Slope (%)	4.6		X Walk 2 Slope (%)	2.4
	X Walk 1 X Slope (%)	3.0		X Walk 2 X Slope (%)	3.4

N/A	Ramp inside XWalk1?	N/A	N/A	Ramp inside XWalk2?	N/A
	Road Slope (%)	1.2	N/A	Clear Space?	N/A
	Road X Slope (%)	5.9	N/A	Clear Space to XWalk (in)	N/A
N/A	Any Obstructions?	N/A	N/A	Storm Grate/Utility Hazard?	N/A
	Obstruction Type			Storm Grate/Utility Type	
		N/A			N/A
			Yes	Surface Condition? (G/P)	Good

Possible Solutions:

Remove & Replace Curb Ramp With Two New Directional Ramps or Equivalent.

R304.5.1, R304.2.2
