Access Compliance Report

Public Rights-of-Way

(Curb Ramps)

Intersection ID: 10036258	Main Street: ROMANY_RD	Cross Street: N/A	Location: SE
ADA ID: 3C31EC906FE2	Ramp Type: PerpDiag	Initial Pass/Fail: Fail	Overall Compliance: No
		Severity Score: 10

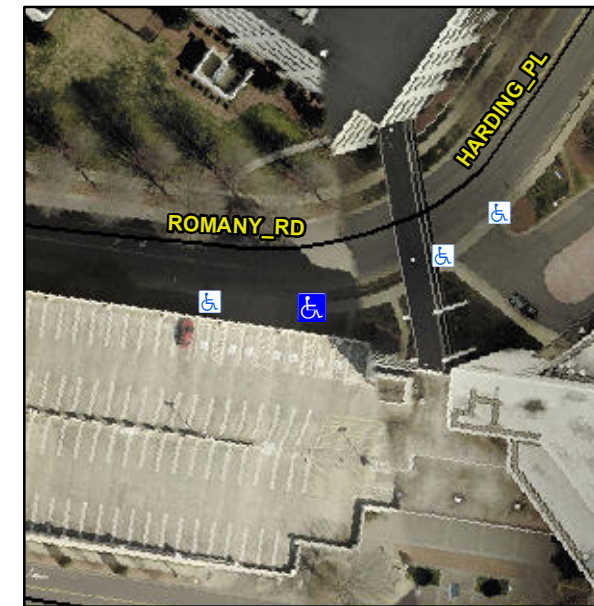
Not Found, R304.5.1, R304.5.3

Compliance	Description	Data	Compliance	Description	Data
N/A	Ramp Length (in)	61.0	Yes	Ramp Slope (%)	5.2
No	Ramp Width (in)	36.5	No	Ramp XSlope (%)	4.7
N/A	Flare Type LT	N/A	N/A	Flare Type RT	N/A
N/A	Flare Slope LT (%)	N/A	N/A	Flare Slope RT (%)	N/A
N/A	Flare Traversable LT?	N/A	N/A	Flare Traversable RT?	N/A
N/A	Landing Length (in)	N/A	N/A	DWS Provided?	N/A
N/A	Landing Width (in)	N/A	N/A	DWS Contrast?	N/A
N/A	Landing Slope (%)	N/A	N/A	DWS Length (in)	N/A
N/A	Landing X Slope (%)	N/A	N/A	DWS Full Width?	N/A
N/A	Landing Curb? (Y/N)	N/A	N/A	DWS Offset (in)	N/A
N/A	Shared Landing?	N/A			
N/A	Gutter Ponding?	N/A	N/A	Gutter Slope (%)	N/A
N/A	Gutter Lip Ht (in)	N/A	N/A	Gutter X Slope (%)	N/A
N/A	Painted X Walk1?	No	N/A	Painted X Walk2?	No
	X Walk 1 Direction	To NE		X Walk 2 Direction	To NW
N/A	X Walk 1 Width (in)	N/A	N/A	X Walk 2 Width (in)	N/A
	X Walk 1 Slope (%)	3.7		X Walk 2 Slope (%)	0.8
	X Walk 1 X Slope (%)	0.7		X Walk 2 X Slope (%)	5.4

N/A	Ramp inside XWalk1?	N/A	N/A	Ramp inside XWalk2?	N/A
	Road Slope (%)	2.4	N/A	Clear Space?	N/A
	Road X Slope (%)	0.0	N/A	Clear Space to XWalk (in)	N/A
N/A	Any Obstructions?	N/A	N/A	Storm Grate/Utility Hazard?	N/A
	Obstruction Type			Storm Grate/Utility Type	
		N/A			N/A
			Yes	Surface Condition? (G/P)	Good

Remove & Replace Curb Ramp With Two New Directional Ramps or Equivalent.
