# Access Compliance Report

## Public Rights-of-Way

### (Curb Ramps)

| Intersection ID: 26426 | Main Street: BRECHIN_DR | Cross Street: FORTROSE_LN | Location: NE |

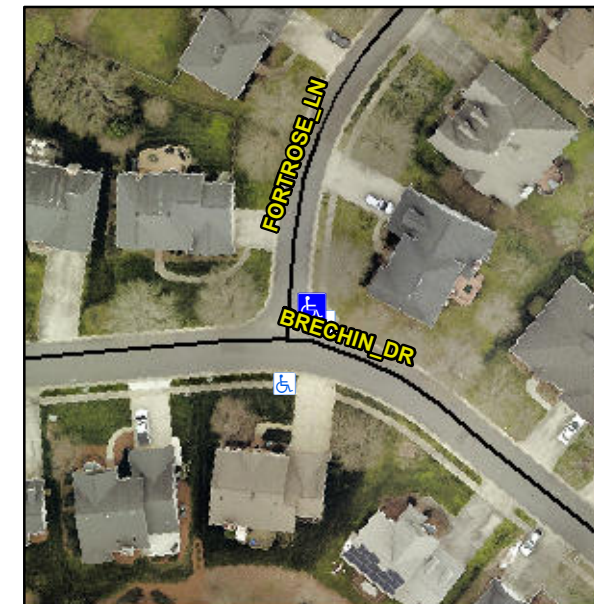
| ADA ID: 3C34AA803057 | Ramp Type: Perp | Initial Pass/Fail: Fail | Overall Compliance: No |
| | | Severity Score: 47.5 | |

| Compliance | Description | Data | Compliance | Description | Data |
|---|---|---|---|---|---|
| N/A | Ramp Length (in) | 94.0 | No | Ramp Slope (%) | 9.8 |
| No | Ramp Width (in) | 29.0 | Yes | Ramp XSlope (%) | 1.2 |

**Remove & Replace Entire Ramp.**

**R304.5.1, R304.2.2**

Total Cost: \$ 1850.00
