Access Compliance Report

Public Rights-of-Way

(Curb Ramps)

| Intersection ID: 50616 | Main Street: PADDLE_OAK_RD | Cross Street: FAWN_LILY | Location: W |

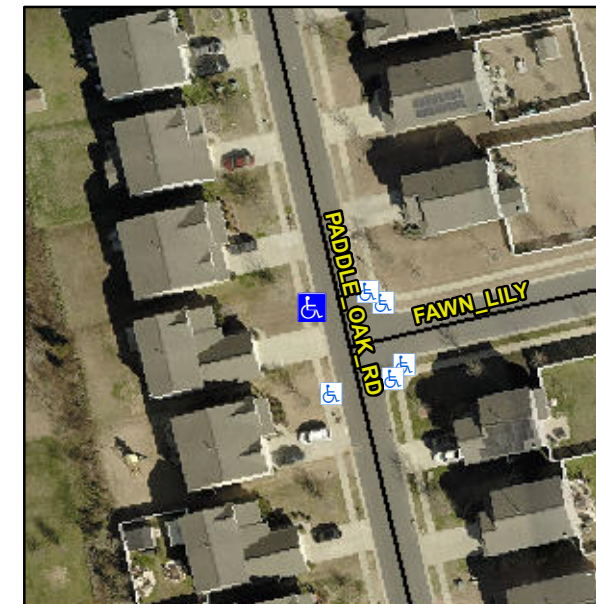
| ADA ID: 3C368F332731 | Ramp Type: Perp | Initial Pass/Fail: Fail | Overall Compliance: No |
| Severity Score: 22.5 | | | |

R304.5.1, R304.2.2, R304.5.3

| Compliance | Description | Data | Compliance | Description | Data |
|---|---|---|---|---|---|
| N/A | Ramp Length (in) | 47.5 | No | Ramp Slope (%) | 10.8 |
| No | Ramp Width (in) | 47.0 | No | Ramp XSlope (%) | 3.2 |

Remove & Replace Entire Ramp.
