# Access Compliance Report

### (Curb Ramps)

| Intersection ID: 54373 | Main Street: BENSEVAL_LN | Cross Street: ARNOTT_LN | Location: SE |
| ADA ID: 3C459457BDEE | Ramp Type: BlendTrans1 | Initial Pass/Fail: Fail | Overall Compliance: No |

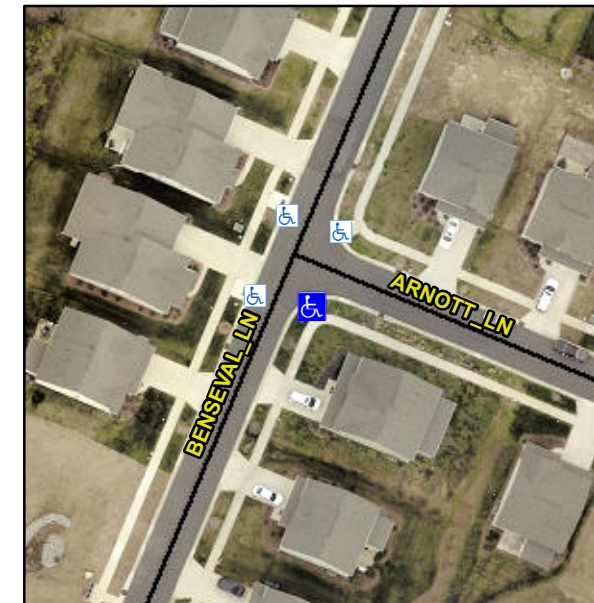
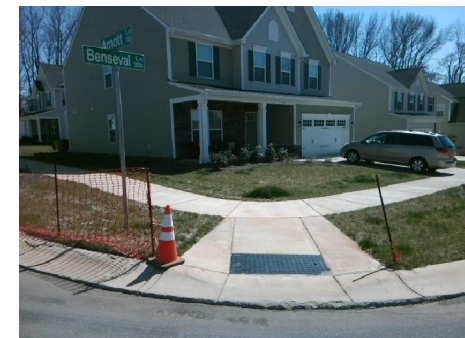
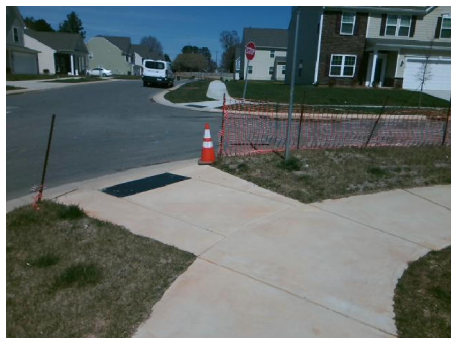
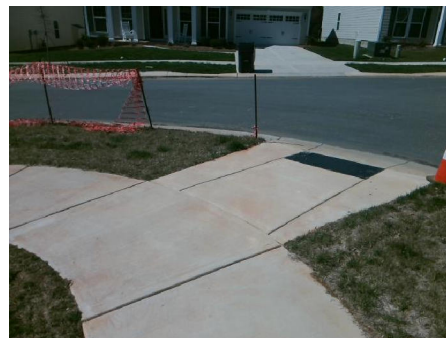
**Not Found, R304.5.1, R304.5.3**

| Compliance | Description | Data | Compliance | Description | Data |
|---|---|---|---|---|---|
| No | Ramp Width (in) | 47.0 | No | BlendTrans XSlope (%) | 4.8 |

**Remove & Replace Curb Ramp With Two New Directional Ramps or Equivalent.**
