Access Compliance Report

Public Rights-of-Way (Curb Ramps)

| Intersection ID: 17138 | Main Street: IDLEWILD_RD | Cross Street: PINEY_GROVE_RD | Location: NE |
| ADA ID: 3C49F7EC29A1 | Ramp Type: Para | Initial Pass/Fail: Fail | Overall Compliance: No |

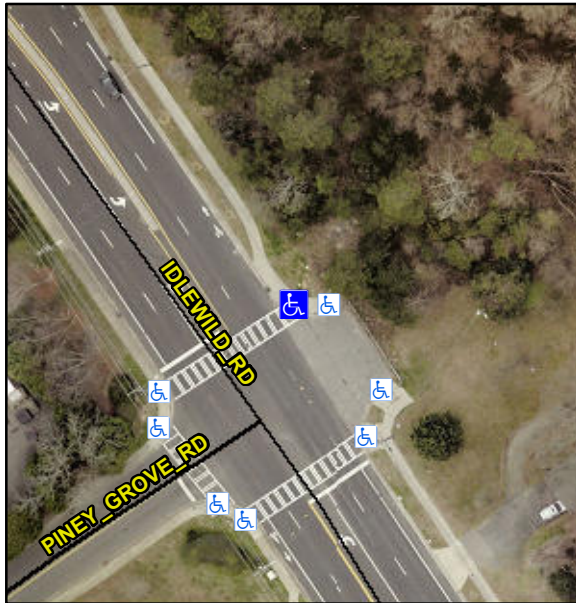
R304.3.2, R304.5.3

| Compliance | Description | Data | Compliance | Description | Data |
|---|---|---|---|---|---|
| No | Ramp Slope LT (%) | 8.5 | Yes | Ramp Slope RT (%) | 7.2 |
| No | Ramp XSlope LT (%) | 2.1 | No | Ramp XSlope RT (%) | 3.1 |

Remove & Replace Entire Ramp.
