# Access Compliance Report

## Public Rights-of-Way

### (Curb Ramps)

Intersection ID: 43188	Main Street: HOVIS_RD	Cross Street: SALEM_CHURCH_RD	Location: NW
ADA ID: 3C534C10EAA0	Ramp Type: Perp	Initial Pass/Fail: Fail	Overall Compliance: No
			Severity Score: 21.25

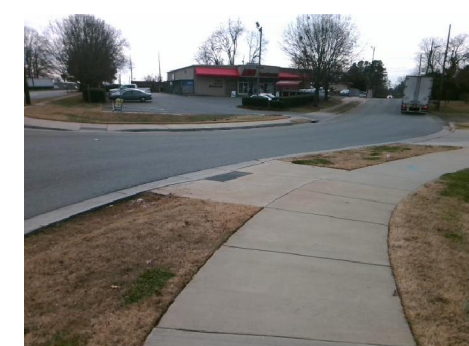
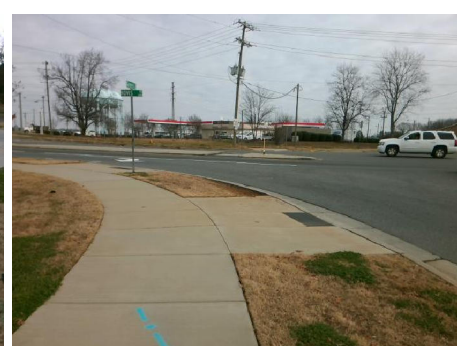
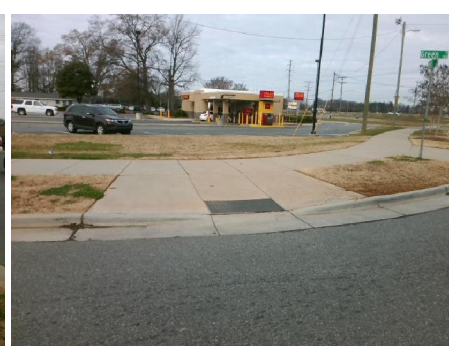
Possible Solutions:		<b>Compliance</b>	<b>Description</b>	<b>Data</b>
	<b>Remove &amp; Replace Entire Ramp.</b>		<b>No</b>	Ramp Length (in)	<b>96.0</b>
			<b>No</b>	Ramp Width (in)	<b>47.5</b>
			<b>N/A</b>	Flare Type LT	<b>N/A</b>
			<b>N/A</b>	Flare Slope LT (%)	<b>N/A</b>
			<b>N/A</b>	Flare Traversable LT?	<b>N/A</b>
			<b>N/A</b>	Landing Length (in)	<b>N/A</b>
			<b>N/A</b>	Landing Width (in)	<b>N/A</b>
			<b>N/A</b>	Landing Slope (%)	<b>N/A</b>
			<b>N/A</b>	Landing X Slope (%)	<b>N/A</b>
<p>Surveyor Notes:</p> <p><b>N/A</b></p> <p>PROW/ADA:</p> <p><b>Not Found, R304.5.1, R304.2.2</b></p>			<b>N/A</b>	Flare Type RT	<b>N/A</b>
			<b>N/A</b>	Flare Slope RT (%)	<b>N/A</b>
			<b>N/A</b>	Flare Traversable RT?	<b>N/A</b>
			<b>N/A</b>	DWS Provided?	<b>N/A</b>
			<b>N/A</b>	DWS Contrast?	<b>N/A</b>
			<b>N/A</b>	DWS Length (in)	<b>N/A</b>

<b>N/A</b>	DWS Full Width?	<b>N/A</b>
			<b>N/A</b>	DWS Offset (in)	<b>N/A</b>
			<b>N/A</b>	Gutter Ponding?	<b>N/A</b>
			<b>N/A</b>	Gutter Lip Ht (in)	<b>N/A</b>
			<b>No</b>	Painted X Walk1?	<b>N/A</b>
			<b>To S</b>	X Walk 1 Direction	<b>N/A</b>
			<b>N/A</b>	X Walk 1 Width (in)	<b>N/A</b>
			<b>1.1</b>	X Walk 1 Slope (%)	<b>N/A</b>
			<b>2.6</b>	X Walk 1 X Slope (%)	<b>N/A</b>
			<b>N/A</b>	Ramp inside XWalk1?	<b>N/A</b>
			<b>N/A</b>	Road Slope (%)	<b>N/A</b>
			<b>N/A</b>	Road X Slope (%)	<b>N/A</b>
			<b>N/A</b>	Any Obstructions?	<b>N/A</b>
				Obstruction Type	<b>N/A</b>
Total Cost:			<b>\$ 1850.00</b>		
			<b>N/A</b>		<b>N/A</b>
			<b>Yes</b>	Surface Condition? (G/P)	<b>Good</b>
