Access Compliance Report

Public Rights-of-Way

(Curb Ramps)

Intersection ID: 7031	Main Street: BROOKSHIRE_BV	Cross Street: OAKDALE_RD	Location: NE
ADA ID: 3C5F309B55F1	Ramp Type: Perp	Initial Pass/Fail: Fail	Overall Compliance: No
Severity Score: 22.5			
Codes/Mitigation Info/Possible Solution		Field Measurements/Component Compliance

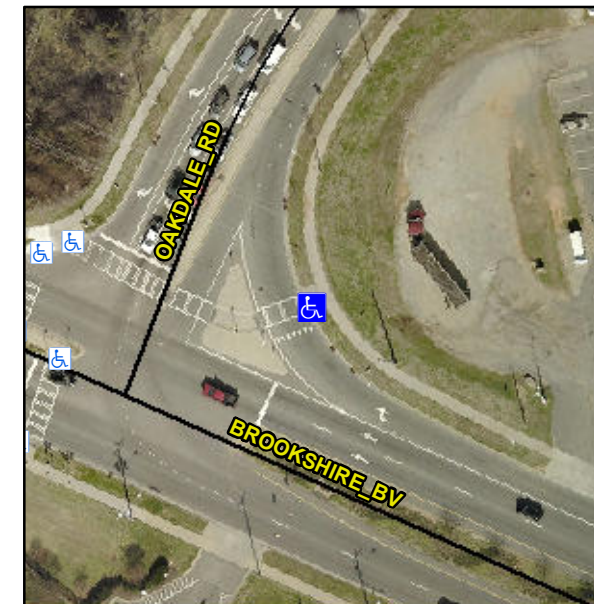
Not Found, R304.5.1, R304.2.2, R304.5.3

Compliance	Description	Data	Compliance	Description	Data
N/A	Ramp Length (in)	95.0	No	Ramp Slope (%)	8.6
No	Ramp Width (in)	45.5	No	Ramp XSlope (%)	2.6
N/A	Flare Type LT	N/A	N/A	Flare Type RT	N/A
N/A	Flare Slope LT (%)	N/A	N/A	Flare Slope RT (%)	N/A
N/A	Flare Traversable LT?	N/A	N/A	Flare Traversable RT?	N/A
N/A	Landing Length (in)	N/A	N/A	DWS Provided?	N/A
N/A	Landing Width (in)	N/A	N/A	DWS Contrast?	N/A
N/A	Landing Slope (%)	N/A	N/A	DWS Length (in)	N/A
N/A	Landing X Slope (%)	N/A	N/A	DWS Full Width?	N/A
N/A	Landing Curb? (Y/N)	N/A	N/A	DWS Offset (in)	N/A
N/A	Shared Landing?	N/A			
N/A	Gutter Ponding?	N/A	N/A	Gutter Slope (%)	N/A
N/A	Gutter Lip Ht (in)	N/A	N/A	Gutter X Slope (%)	N/A
N/A	Painted X Walk1?	Yes	N/A	Painted X Walk2?	N/A
	X Walk 1 Direction	To SW		X Walk 2 Direction	N/A
N/A	X Walk 1 Width (in)	112.0	N/A	X Walk 2 Width (in)	N/A
	X Walk 1 Slope (%)	1.9		X Walk 2 Slope (%)	N/A
	X Walk 1 X Slope (%)	1.6		X Walk 2 X Slope (%)	N/A

N/A	Ramp inside XWalk1?	Yes	N/A	Ramp inside XWalk2?	N/A
	Road Slope (%)	N/A	N/A	Clear Space?	N/A
	Road X Slope (%)	N/A	N/A	Clear Space to XWalk (in)	N/A
N/A	Any Obstructions?	N/A	N/A	Storm Grate/Utility Hazard?	N/A
	Obstruction Type			Storm Grate/Utility Type	
		N/A			N/A
			Yes	Surface Condition? (G/P)	Good

Remove & Replace Entire Ramp.
