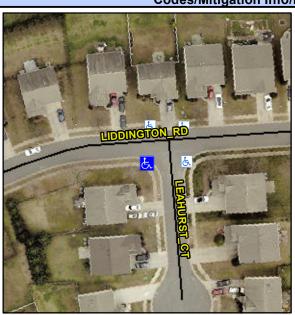
Intersection ID: 47272Main Street: LEAHURST_CTCross Street: LIDDINGTON_RDLocation:SWADA ID: 3C6A055B7694Ramp Type: PerpDiagInitial Pass/Fail: FailOverall Compliance: NoSeverity Score:10

Field Measurements/Component Compliance							
Cor	npliance Description	Data	Comp	oliance Description	Data		
N/A	Ramp Length (in)	46.5	Yes	Ramp Slope (%)	6.3		
No	Ramp Width (in)	44.0	No	Ramp XSlope (%)	3.7		
N/A	Flare Type LT	N/A	N/A	Flare Type RT	N/A		
N/A	Flare Slope LT (%)	N/A	N/A	Flare Slope RT (%)	N/A		
N/A	Flare Traversable LT?	N/A	N/A	Flare Traversable RT?	N/A		
N/A	Landing Length (in)	N/A	N/A	DWS Provided?	N/A		
N/A	Landing Width (in)	N/A	N/A	DWS Contrast?	N/A		
N/A	Landing Slope (%)	N/A	N/A	DWS Length (in)	N/A		
N/A	Landing X Slope (%)	N/A	N/A	DWS Full Width?	N/A		
N/A	Landing Curb? (Y/N)	N/A	N/A	DWS Offset (in)	N/A		
N/A	Shared Landing?	N/A					
N/A	Gutter Ponding?	N/A	N/A	Gutter Slope (%)	N/A		
N/A	Gutter Lip Ht (in)	N/A	N/A	Gutter X Slope (%)	N/A		
N/A	Painted X Walk1?	No	N/A	Painted X Walk2?	No		
	X Walk 1 Direction	To E		X Walk 2 Direction	To N		
N/A	X Walk 1 Width (in)	N/A	N/A	X Walk 2 Width (in)	N/A

X Walk 1 Slope (%)	5.0		X Walk 2 Slope (%)	2.6		
	X Walk 1 X Slope (%)	0.4		X Walk 2 X Slope (%)	3.8		
N/A	Ramp inside XWalk1?	N/A	N/A	Ramp inside XWalk2?	N/A		
	Road Slope (%)	2.1	N/A	Clear Space?	N/A		
	Road X Slope (%)	3.7	N/A	Clear Space to XWalk (in)	N/A		
N/A	Any Obstructions?	N/A	N/A	Storm Grate/Utility Hazard?	N/A		
	Obstruction Type			Storm Grate/Utility Type			
		N/A			N/A		
			Yes	Surface Condition? (G/P)	Good

Possible Solutions:	
Remove & Replace Curb Ramp With Two New Directional Ramps or Equivalent.	
Surveyor Notes: N/A	
PROW/ADA: Not Found, R304.5.1, R304.5.3
