## **Access Compliance Report Public Rights-of-Way** (Curb Ramps)

Intersection ID: 3506 Main Street: MT\_HOLLY-HUNTERSVILLE\_RDCross Street: BEATTIES\_FORD\_RD Location: SE ADA ID: 3C6F08E69A5C Ramp Type: Perp Initial Pass/Fail: Fail **Overall Compliance: No Severity Score:** 10

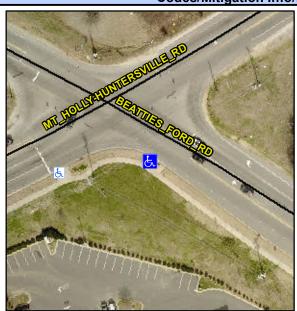
Field Measurements/Component Compliance					
Comp	Compliance Description		Comp	liance Description	Data
N/A	Ramp Length (in)	94.0	Yes	Ramp Slope (%)	6.5
No	Ramp Width (in)	46.0	No	Ramp XSlope (%)	3.6
N/A	Flare Type LT	N/A	N/A	Flare Type RT	N/A
N/A	Flare Slope LT (%)	N/A	N/A	Flare Slope RT (%)	N/A
N/A	Flare Traversable LT?	N/A	N/A	Flare Traversable RT?	N/A
N/A	Landing Length (in)	N/A	N/A	DWS Provided?	N/A
N/A	Landing Width (in)	N/A	N/A	DWS Contrast?	N/A
N/A	Landing Slope (%)	N/A	N/A	DWS Length (in)	N/A
N/A	Landing X Slope (%)	N/A	N/A	DWS Full Width?	N/A
N/A	Landing Curb? (Y/N)	N/A	N/A	DWS Offset (in)	N/A
N/A	Shared Landing?	N/A			
N/A	Gutter Ponding?	N/A	N/A	Gutter Slope (%)	N/A
N/A	Gutter Lip Ht (in)	N/A	N/A	Gutter X Slope (%)	N/A
N/A	Painted X Walk1?	No	N/A	Painted X Walk2?	N/A
	X Walk 1 Direction	To NE		X Walk 2 Direction	N/A
N/A	X Walk 1 Width (in)	N/A	N/A	X Walk 2 Width (in)	N/A
	X Walk 1 Slope (%)	2.3		X Walk 2 Slope (%)	N/A

X Walk 1 X Slope (%)	2.7		X Walk 2 X Slope (%)	N/A
N/A	Ramp inside XWalk1?	N/A	N/A	Ramp inside XWalk2?	N/A
	Road Slope (%)	2.7	N/A	Clear Space?	N/A
	Road X Slope (%)	2.3	N/A	Clear Space to XWalk (in)	N/A
N/A	Any Obstructions?	N/A	N/A	Storm Grate/Utility Hazard?	N/A
	Obstruction Type			Storm Grate/Utility Type	
		N/A			N/A
			Yes	Surface Condition? (G/P)	Good
Sant all		·

**BEATTIES FORD RD** Street 1 Name Signal Stop Condition-Street 2 Street 2 Name N/A Stop Condition-Street 1 N/A Possible Solutions: Remove & Replace Entire Ramp. Surveyor Notes: N/A PROW/ADA: Not Found, R304.5.1, R304.5.3
