Access Compliance Report

Public Rights-of-Way

(Curb Ramps)

Intersection ID: 52919	Main Street: HOOVER_CREEK_BV	Cross Street: WALKER_BRANCH_DR	Location: NE
ADA ID: 3C719C930EF5	Ramp Type: Perp	Initial Pass/Fail: Fail	Overall Compliance: No
Severity Score: 10			
Codes/Mitigation Info/Possible Solution		Field Measurements/Component Compliance

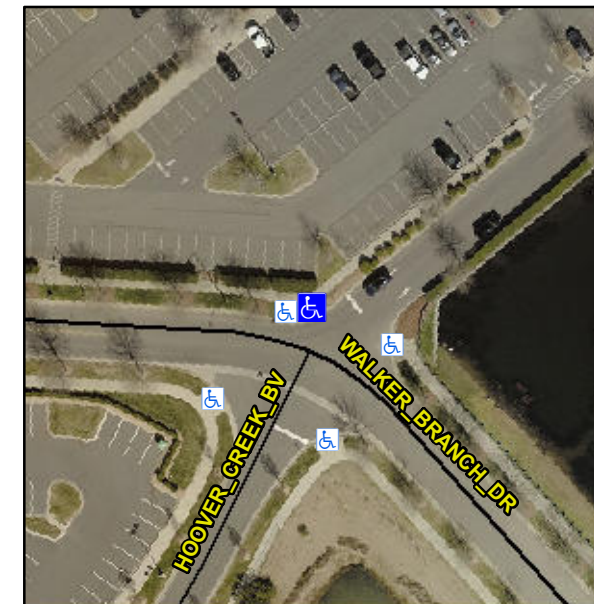
Not Found, R304.5.1, R304.5.3

Compliance	Description	Data	Compliance	Description	Data
N/A	Ramp Length (in)	75.0	Yes	Ramp Slope (%)	7.8
No	Ramp Width (in)	43.0	No	Ramp XSlope (%)	4.0
N/A	Flare Type LT	N/A	N/A	Flare Type RT	N/A
N/A	Flare Slope LT (%)	N/A	N/A	Flare Slope RT (%)	N/A
N/A	Flare Traversable LT?	N/A	N/A	Flare Traversable RT?	N/A
N/A	Landing Length (in)	N/A	N/A	DWS Provided?	N/A
N/A	Landing Width (in)	N/A	N/A	DWS Contrast?	N/A
N/A	Landing Slope (%)	N/A	N/A	DWS Length (in)	N/A
N/A	Landing X Slope (%)	N/A	N/A	DWS Full Width?	N/A
N/A	Landing Curb? (Y/N)	N/A	N/A	DWS Offset (in)	N/A
N/A	Shared Landing?	N/A			
N/A	Gutter Ponding?	N/A	N/A	Gutter Slope (%)	N/A
N/A	Gutter Lip Ht (in)	N/A	N/A	Gutter X Slope (%)	N/A
N/A	Painted X Walk1?	No	N/A	Painted X Walk2?	N/A
	X Walk 1 Direction	To SE		X Walk 2 Direction	N/A
N/A	X Walk 1 Width (in)	N/A	N/A	X Walk 2 Width (in)	N/A
	X Walk 1 Slope (%)	2.4		X Walk 2 Slope (%)	N/A
	X Walk 1 X Slope (%)	3.4		X Walk 2 X Slope (%)	N/A

N/A	Ramp inside XWalk1?	N/A	N/A	Ramp inside XWalk2?	N/A
	Road Slope (%)	N/A	N/A	Clear Space?	N/A
	Road X Slope (%)	N/A	N/A	Clear Space to XWalk (in)	N/A
N/A	Any Obstructions?	N/A	N/A	Storm Grate/Utility Hazard?	N/A
	Obstruction Type			Storm Grate/Utility Type	
		N/A			N/A
			Yes	Surface Condition? (G/P)	Good

Possible Solutions:

Remove & Replace Entire Ramp.
