# Access Compliance Report

## Public Rights-of-Way (Curb Ramps)

Intersection ID: 5588	Main Street: CARVER_BV	Cross Street: ROCKWELL_BV	Location:	E
ADA ID: 3C816C49BE1A	Ramp Type: Para	Initial Pass/Fail: Fail	Overall Compliance: No	Severity Score: 22.5
Codes/Mitigation Info/Possible Solution		Field Measurements/Component Compliance

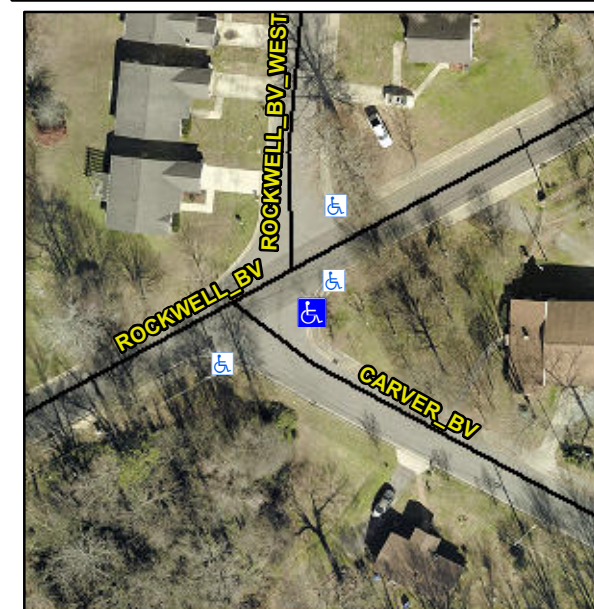
Compliance	Description	Data	Compliance	Description	Data
N/A	Ramp Length LT (in)	57.5	N/A	Ramp Length RT (in)	58.0
No	Ramp Width LT (in)	36.0	No	Ramp Width RT (in)	36.0
Yes	Ramp Slope LT (%)	6.0	No	Ramp Slope RT (%)	9.1
No	Ramp XSlope LT (%)	2.1	No	Ramp XSlope RT (%)	3.0
N/A	Landing Length (in)	N/A	N/A	DWS Provided?	N/A
N/A	Landing Width (in)	N/A	N/A	DWS Contrast?	N/A
N/A	Landing Slope (%)	N/A	N/A	DWS Length (in)	N/A
N/A	Landing X Slope (%)	N/A	N/A	DWS Full Width?	N/A
N/A	Landing Curb? (Y/N)	N/A	N/A	DWS Offset (in)	N/A
N/A	Shared Landing?	N/A			
N/A	Gutter Ponding?	N/A	N/A	Gutter Slope (%)	N/A
N/A	Gutter Lip Ht (in)	N/A	N/A	Gutter X Slope (%)	N/A
N/A	Painted X Walk1?	No	N/A	Painted X Walk2?	N/A
	X Walk 1 Direction	To SW		X Walk 2 Direction	N/A
N/A	X Walk 1 Width (in)	N/A	N/A	X Walk 2 Width (in)	N/A
	X Walk 1 Slope (%)	0.8		X Walk 2 Slope (%)	N/A
	X Walk 1 X Slope (%)	3.2		X Walk 2 X Slope (%)	N/A
N/A	Ramp inside XWalk1?	N/A	N/A	Ramp inside XWalk2?	N/A

Road Slope (%)	N/A	N/A	Clear Space?	N/A
	Road X Slope (%)	N/A	N/A	Clear Space to XWalk (in)	N/A
N/A	Any Obstructions?	N/A	N/A	Storm Grate/Utility Hazard?	N/A
	Obstruction Type			Storm Grate/Utility Type	
		N/A			N/A
			Yes	Surface Condition? (G/P)	Good
			N/A	Curb Slope (%)	20.6

**Remove & Replace Entire Ramp.**

**R304.5.1, R304.5.3, R304.3.2**
