# Access Compliance Report

## Public Rights-of-Way

### (Curb Ramps)

| Intersection ID: 2513 | Main Street: BENTGRASS_RUN_DR | Cross Street: COPPERMINE_LN | Location: SW |

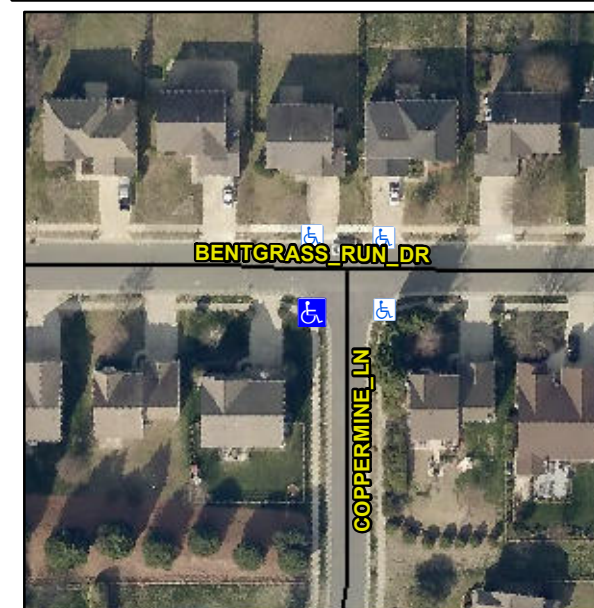
| ADA ID: 3C82395A2ECF | Ramp Type: PerpDiag | Initial Pass/Fail: Pass | Overall Compliance: No |
| Severity Score: 22.5 | | | |

**R304.2.2-Perp, R304.3.2-Para, R304.5.3, R305, R302.7.2, R304.5.4**

| Compliance | Description | Data | Compliance | Description | Data |
|---|---|---|---|---|---|
| Yes | Landing Length (in) | 48.0 | No | DWS Provided? | No |
| No | Landing Slope (%) | 3.1 | N/A | DWS Length (in) | N/A |
| No | Landing X Slope (%) | 2.9 | N/A | DWS Full Width? | No |
| Yes | Gutter Ponding? | No | No | Gutter Slope (%) | 7.1 |
| No | Gutter Lip Ht (in) | 0.5 | Yes | Gutter X Slope (%) | 1.3 |

**Remove & Replace Curb Ramp With Two New Directional Ramps or Equivalent. Remove & Replace Gutter.**

Total Cost: \$ 3950.00
