## Access Compliance Report Public Rights-of-Way (Curb Ramps)

Intersection ID: 16513Main Street:BILTMORE\_DRCross Street:COLVILLE\_RDLocation:SWADA ID: 3C835C37D2D6Ramp Type:BlendTrans2Initial Pass/Fail:FailOverall Compliance:NoSeverity Score:1.25

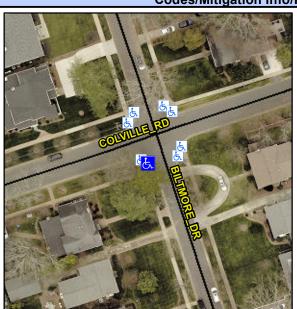
PROW/ADA:
R304.5.3

Compliance Description Data Compliance Description Data					
N/A	Ramp Length (in)	64.0	Yes	BlendTrans Slope (%)	4.7
Yes	Ramp Width (in)	58.5	No	BlendTrans XSlope (%)	3.6
N/A	Flare Type LT	N/A	N/A	Flare Type RT	N/A
N/A	Flare Slope LT (%)	N/A	N/A	Flare Slope RT (%)	N/A
N/A	Flare Traversable LT?	N/A	N/A	Flare Traversable RT?	N/A
N/A	Landing Length (in)	N/A	N/A	DWS Provided?	N/A
N/A	Landing Width (in)	N/A	N/A	DWS Contrast?	N/A
N/A	Landing Slope (%)	N/A	N/A	DWS Length (in)	N/A
N/A	Landing X Slope (%)	N/A	N/A	DWS Full Width?	N/A
N/A N/A	Landing X Slope (%) Landing Curb? (Y/N)	N/A N/A	N/A N/A	DWS Offset (in)	N/A N/A
N/A	Shared Landing?	N/A N/A	IN/A	DWS Offset (III)	N/A
N/A N/A	Gutter Ponding?	Yes	N/A	Cuttor Clana (%)	N/A

•			Gutter Slope (%)	
N/A	Gutter Lip Ht (in)	N/A	N/A	Gutter X Slope (%)	N/A
N/A	Painted X Walk1?	No	N/A	Painted X Walk2?	N/A
	X Walk 1 Direction	To NE		X Walk 2 Direction	N/A
	X Walk 1 Width (in)	N/A		X Walk 2 Width (in)	N/A
	X Walk 1 Slope (%)	2.9		X Walk 2 Slope (%)	N/A
	X Walk 1 X Slope (%)	0.8		X Walk 2 X Slope (%)	N/A
N/A	Ramp inside XWalk1?	N/A	N/A	Ramp inside XWalk2?	N/A
	Road Slope (%)	0.8		Clear Space?	N/A
	Road X Slope (%)	2.9	N/A	Clear Space to XWalk (in)	N/A
N/A	Any Obstructions?	N/A	N/A	Storm Grate/Utility Hazard?	N/A
	Obstruction Type			Storm Grate/Utility Type	
		N/A			N/A
			Yes	Surface Condition? (G/P)	Good
			N/A	Curb Slope (%)	0.7

Remove & Replace Curb Ramp With
Two New Directional Ramps or
Equivalent.
