# Access Compliance Report

## Public Rights-of-Way

### (Curb Ramps)

| Intersection ID: 17455 | Main Street: IDLEWILD_RD | Cross Street: LYNWORTH_PL | Location: SW |

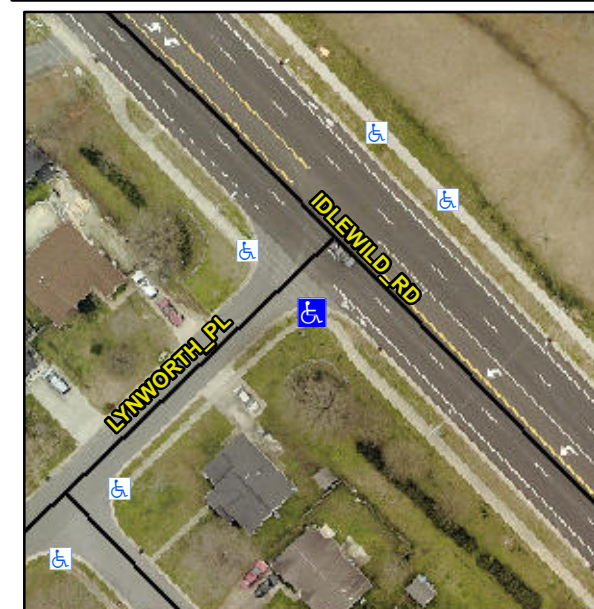
| ADA ID: 3C858C24C0EE | Ramp Type: PerpDiag | Initial Pass/Fail: Fail | Overall Compliance: No |
| Severity Score: 21.25 | | | |

**Not Found, R304.5.1, R304.2.2**

| Compliance | Description | Data | Compliance | Description | Data |
|---|---|---|---|---|---|
| N/A | Ramp Length (in) | 51.0 | No | Ramp Slope (%) | 11.0 |
| No | Ramp Width (in) | 41.0 | Yes | Ramp XSlope (%) | 0.7 |

**Remove & Replace Curb Ramp With Two New Directional Ramps or Equivalent.**

Total Cost: \$ 3200.00
