# Access Compliance Report

## Public Rights-of-Way

| Intersection ID: 10018981 | Main Street: DEVONGATE_LN | Cross Street: DEVONGATE_LN | Location: NW |
| ADA ID: 3C904330034B | Ramp Type: PerpDiag | Initial Pass/Fail: Fail | Overall Compliance: No |

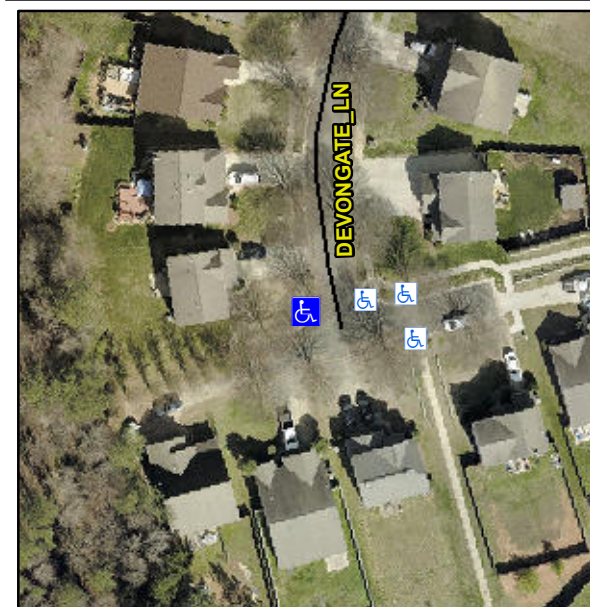
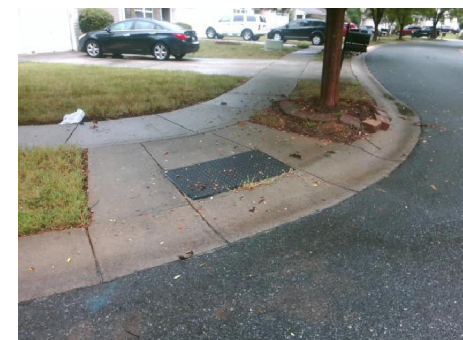
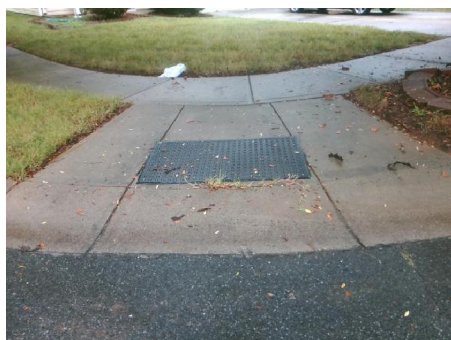
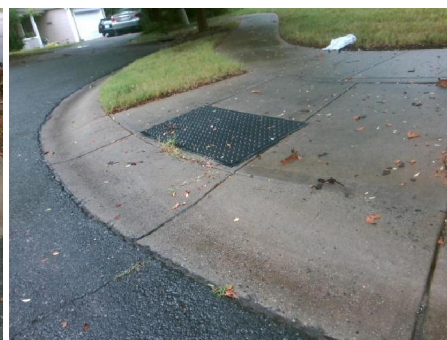
**Not Found, R304.5.1, R304.5.3**

| Compliance | Description | Data | Compliance | Description | Data |
|---|---|---|---|---|---|
| N/A | Ramp Length (in) | 58.0 | Yes | Ramp Slope (%) | 6.4 |
| No | Ramp Width (in) | 34.5 | No | Ramp XSlope (%) | 3.6 |

**Remove & Replace Curb Ramp With Two New Directional Ramps or Equivalent.**
