Access Compliance Report

Public Rights-of-Way

(Curb Ramps)

Intersection ID: 27755	Main Street: BALLANTYNE CROSSING AV	Cross Street: NOLEN LN	Location: NW
ADA ID: 3C91EED85AB2	Ramp Type: Perp	Initial Pass/Fail: Fail	Overall Compliance: No
		Severity Score: 37.5

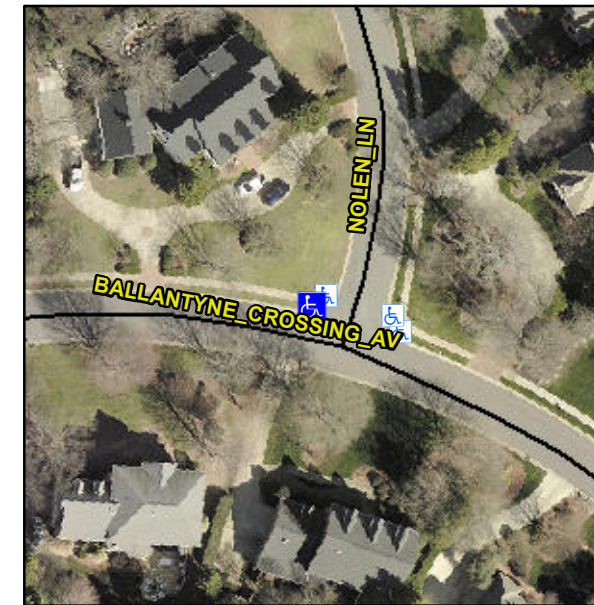
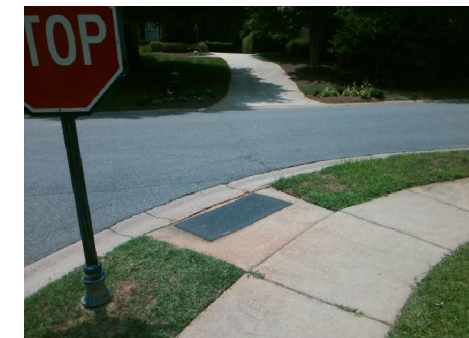
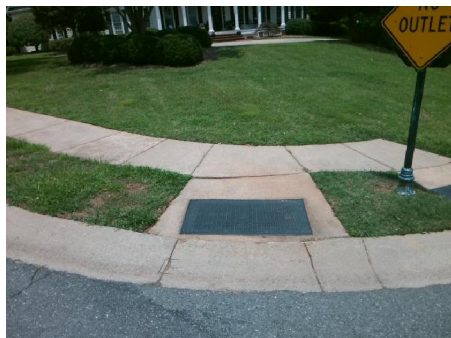
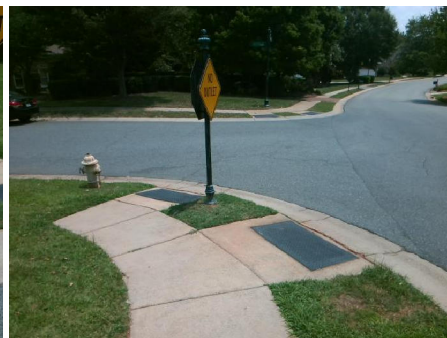
Not Found, R304.2.2, R304.5.3

Compliance	Description	Data	Compliance	Description	Data
N/A	Ramp Length (in)	53.0	No	Ramp Slope (%)	8.4
Yes	Ramp Width (in)	48.0	No	Ramp XSlope (%)	8.9
N/A	Flare Type LT	N/A	N/A	Flare Type RT	N/A
N/A	Flare Slope LT (%)	N/A	N/A	Flare Slope RT (%)	N/A
N/A	Flare Traversable LT?	N/A	N/A	Flare Traversable RT?	N/A
N/A	Landing Length (in)	N/A	N/A	DWS Provided?	N/A
N/A	Landing Width (in)	N/A	N/A	DWS Contrast?	N/A
N/A	Landing Slope (%)	N/A	N/A	DWS Length (in)	N/A
N/A	Landing X Slope (%)	N/A	N/A	DWS Full Width?	N/A
N/A	Landing Curb? (Y/N)	N/A	N/A	DWS Offset (in)	N/A
N/A	Shared Landing?	N/A			
N/A	Gutter Ponding?	N/A	N/A	Gutter Slope (%)	N/A
N/A	Gutter Lip Ht (in)	N/A	N/A	Gutter X Slope (%)	N/A
N/A	Painted X Walk1?	No	N/A	Painted X Walk2?	N/A
	X Walk 1 Direction	To SW		X Walk 2 Direction	N/A
N/A	X Walk 1 Width (in)	N/A	N/A	X Walk 2 Width (in)	N/A
	X Walk 1 Slope (%)	8.5		X Walk 2 Slope (%)	N/A
	X Walk 1 X Slope (%)	7.9		X Walk 2 X Slope (%)	N/A

N/A	Ramp inside XWalk1?	N/A	N/A	Ramp inside XWalk2?	N/A
	Road Slope (%)	N/A	N/A	Clear Space?	N/A
	Road X Slope (%)	N/A	N/A	Clear Space to XWalk (in)	N/A
N/A	Any Obstructions?	N/A	N/A	Storm Grate/Utility Hazard?	N/A
	Obstruction Type			Storm Grate/Utility Type	
		N/A			N/A
			Yes	Surface Condition? (G/P)	Good

Possible Solutions:

Remove & Replace Entire Ramp.
