# Access Compliance Report

## Public Rights-of-Way

### (Curb Ramps)

Intersection ID: 12413	Main Street: N_BREVARD_ST	Cross Street: E_6TH_ST	Location: S
ADA ID: 3C9D6B8B728B	Ramp Type: PerpDiag	Initial Pass/Fail: Fail	Overall Compliance: No
		Severity Score: 35

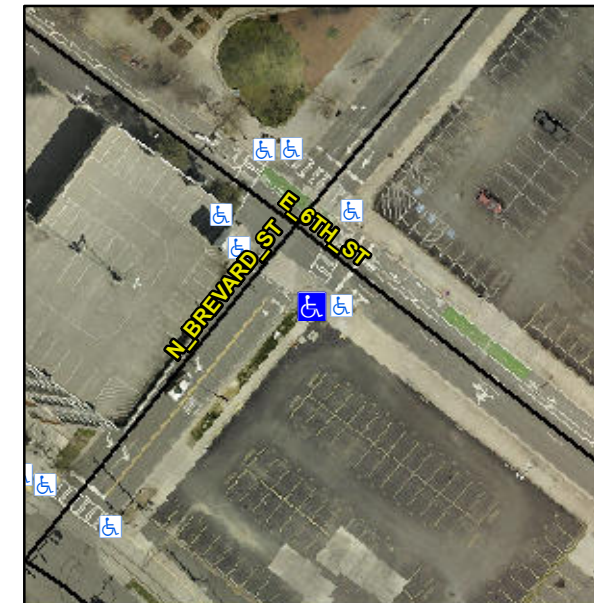
**Not Found, R304.5.1**

Compliance	Description	Data	Compliance	Description	Data
N/A	Ramp Length (in)	84.0	Yes	Ramp Slope (%)	8.0
No	Ramp Width (in)	24.0	Yes	Ramp XSlope (%)	0.3
N/A	Flare Type LT	N/A	N/A	Flare Type RT	N/A
N/A	Flare Slope LT (%)	N/A	N/A	Flare Slope RT (%)	N/A
N/A	Flare Traversable LT?	N/A	N/A	Flare Traversable RT?	N/A
N/A	Landing Length (in)	N/A	N/A	DWS Provided?	N/A
N/A	Landing Width (in)	N/A	N/A	DWS Contrast?	N/A
N/A	Landing Slope (%)	N/A	N/A	DWS Length (in)	N/A
N/A	Landing X Slope (%)	N/A	N/A	DWS Full Width?	N/A
N/A	Landing Curb? (Y/N)	N/A	N/A	DWS Offset (in)	N/A
N/A	Shared Landing?	N/A			
N/A	Gutter Ponding?	N/A	N/A	Gutter Slope (%)	N/A
N/A	Gutter Lip Ht (in)	N/A	N/A	Gutter X Slope (%)	N/A
N/A	Painted X Walk1?	Yes	N/A	Painted X Walk2?	Yes
	X Walk 1 Direction	To NE		X Walk 2 Direction	To NW
N/A	X Walk 1 Width (in)	112.0	N/A	X Walk 2 Width (in)	112.0
	X Walk 1 Slope (%)	1.8		X Walk 2 Slope (%)	1.0
	X Walk 1 X Slope (%)	0.9		X Walk 2 X Slope (%)	0.6

N/A	Ramp inside XWalk1?	Yes	N/A	Ramp inside XWalk2?	Yes
	Road Slope (%)	0.5	N/A	Clear Space?	N/A
	Road X Slope (%)	1.3	N/A	Clear Space to XWalk (in)	N/A
N/A	Any Obstructions?	N/A	N/A	Storm Grate/Utility Hazard?	N/A
	Obstruction Type			Storm Grate/Utility Type	
		N/A			N/A
		Yes		Surface Condition? (G/P)	Good

**Remove & Replace Curb Ramp With Two New Directional Ramps or Equivalent.**
