Access Compliance Report

Public Rights-of-Way

(Curb Ramps)

| Intersection ID: 12013 | Main Street: FREEDOM_DR | Cross Street: W_MOREHEAD_ST | Location: S |

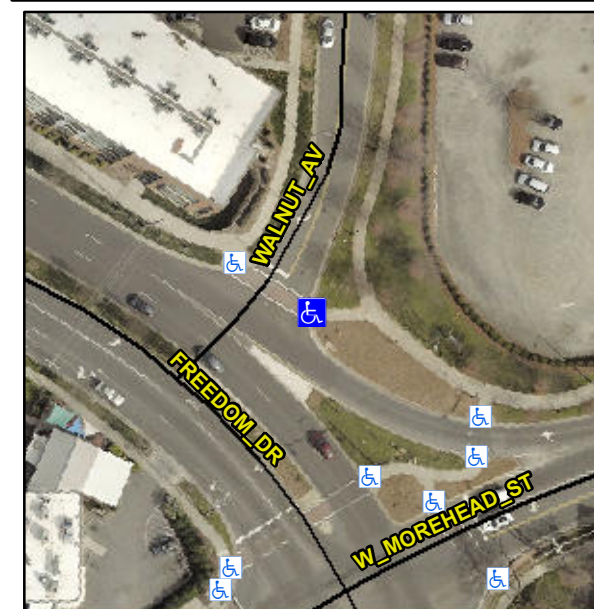
| ADA ID: 3CA1149029BB | Ramp Type: Perp | Initial Pass/Fail: Fail | Overall Compliance: No |

Not Found, R304.5.1, R304.5.3

| Compliance | Description | Data | Compliance | Description | Data |
|---|---|---|---|---|---|
| No | Ramp Width (in) | 47.5 | No | Ramp XSlope (%) | 3.1 |

Remove & Replace Entire Ramp.
