# Access Compliance Report

## Public Rights-of-Way

### (Curb Ramps)

Intersection ID: 15316	Main Street: CARLING_AV	Cross Street: CHARLOTTE_DR	Location: W
ADA ID: 3CAFF1FA940D	Ramp Type: Perp	Initial Pass/Fail: Fail	Overall Compliance: No
		Severity Score: 12.5

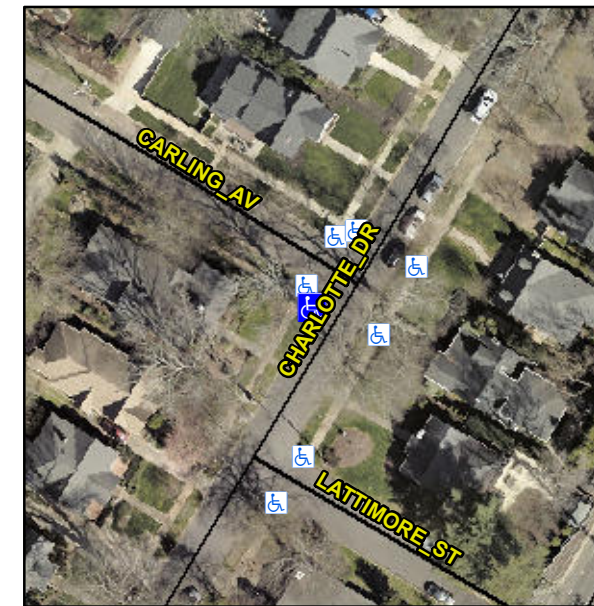
**Not Found, R304.2.2**

Compliance	Description	Data	Compliance	Description	Data
N/A	Ramp Length (in)	74.0	No	Ramp Slope (%)	10.1
Yes	Ramp Width (in)	48.0	Yes	Ramp XSlope (%)	1.6
N/A	Flare Type LT	N/A	N/A	Flare Type RT	N/A
N/A	Flare Slope LT (%)	N/A	N/A	Flare Slope RT (%)	N/A
N/A	Flare Traversable LT?	N/A	N/A	Flare Traversable RT?	N/A
N/A	Landing Length (in)	N/A	N/A	DWS Provided?	N/A
N/A	Landing Width (in)	N/A	N/A	DWS Contrast?	N/A
N/A	Landing Slope (%)	N/A	N/A	DWS Length (in)	N/A
N/A	Landing X Slope (%)	N/A	N/A	DWS Full Width?	N/A
N/A	Landing Curb? (Y/N)	N/A	N/A	DWS Offset (in)	N/A
N/A	Shared Landing?	N/A			
N/A	Gutter Ponding?	N/A	N/A	Gutter Slope (%)	N/A
N/A	Gutter Lip Ht (in)	N/A	N/A	Gutter X Slope (%)	N/A
N/A	Painted X Walk1?	No	N/A	Painted X Walk2?	N/A
	X Walk 1 Direction	To SE		X Walk 2 Direction	N/A
N/A	X Walk 1 Width (in)	N/A	N/A	X Walk 2 Width (in)	N/A
	X Walk 1 Slope (%)	3.8		X Walk 2 Slope (%)	N/A
	X Walk 1 X Slope (%)	1.1		X Walk 2 X Slope (%)	N/A

N/A	Ramp inside XWalk1?	N/A	N/A	Ramp inside XWalk2?	N/A
	Road Slope (%)	N/A	N/A	Clear Space?	N/A
	Road X Slope (%)	N/A	N/A	Clear Space to XWalk (in)	N/A
N/A	Any Obstructions?	N/A	N/A	Storm Grate/Utility Hazard?	N/A
	Obstruction Type			Storm Grate/Utility Type	
		N/A			N/A
			Yes	Surface Condition? (G/P)	Good

**Remove & Replace Entire Ramp.**

Total Cost: \$ 1850.00
