Access Compliance Report

Public Rights-of-Way

(Curb Ramps)

Intersection ID: 12519	Main Street: E_6TH_ST	Cross Street: N_CALDWELL_ST	Location: E
ADA ID: 3CBDB453C7A3	Ramp Type: Perp	Initial Pass/Fail: Fail	Overall Compliance: No
		Severity Score: 8.75

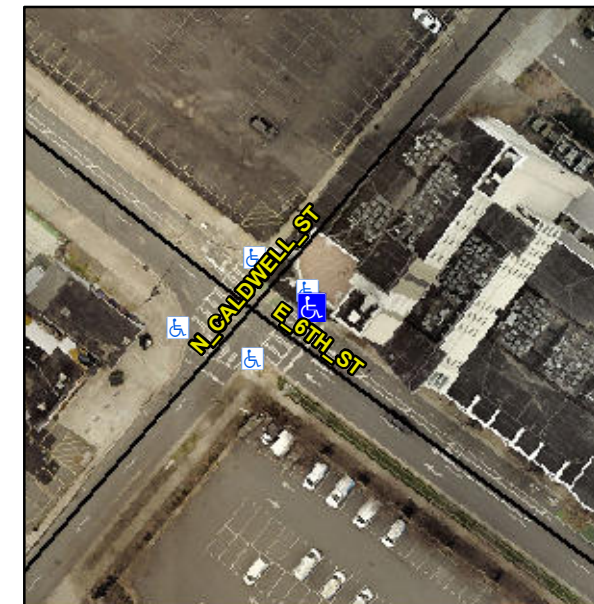
Not Found, R304.5.1

Compliance	Description	Data	Compliance	Description	Data
N/A	Ramp Length (in)	90.0	Yes	Ramp Slope (%)	7.8
No	Ramp Width (in)	47.5	Yes	Ramp XSlope (%)	0.5
N/A	Flare Type LT	N/A	N/A	Flare Type RT	N/A
N/A	Flare Slope LT (%)	N/A	N/A	Flare Slope RT (%)	N/A
N/A	Flare Traversable LT?	N/A	N/A	Flare Traversable RT?	N/A
N/A	Landing Length (in)	N/A	N/A	DWS Provided?	N/A
N/A	Landing Width (in)	N/A	N/A	DWS Contrast?	N/A
N/A	Landing Slope (%)	N/A	N/A	DWS Length (in)	N/A
N/A	Landing X Slope (%)	N/A	N/A	DWS Full Width?	N/A
N/A	Landing Curb? (Y/N)	N/A	N/A	DWS Offset (in)	N/A
N/A	Shared Landing?	N/A			
N/A	Gutter Ponding?	N/A	N/A	Gutter Slope (%)	N/A
N/A	Gutter Lip Ht (in)	N/A	N/A	Gutter X Slope (%)	N/A
N/A	Painted X Walk1?	Yes	N/A	Painted X Walk2?	N/A
	X Walk 1 Direction	To SW		X Walk 2 Direction	N/A
N/A	X Walk 1 Width (in)	108.5	N/A	X Walk 2 Width (in)	N/A
	X Walk 1 Slope (%)	8.7		X Walk 2 Slope (%)	N/A
	X Walk 1 X Slope (%)	2.2		X Walk 2 X Slope (%)	N/A

Remove & Replace Entire Ramp.
