Access Compliance Report Public Rights-of-Way (Curb Ramps)

Intersection ID: 10776	Main Street: CAROL_AV	Cross Street: STATE_ST	Location: SE
ADA ID: 3CCA52B39D5E	Ramp Type: BlendTrans2	Initial Pass/Fail: Fail	Overall Compliance: No Severity Score: 8.75

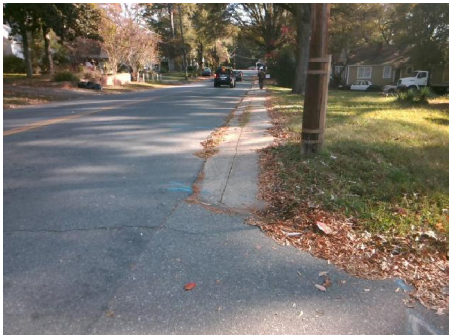
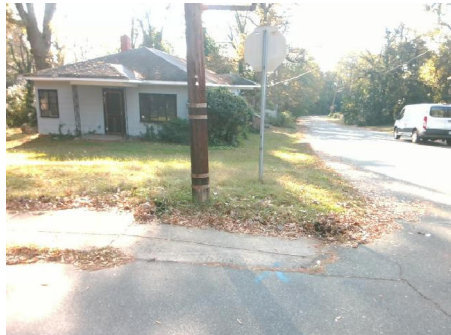
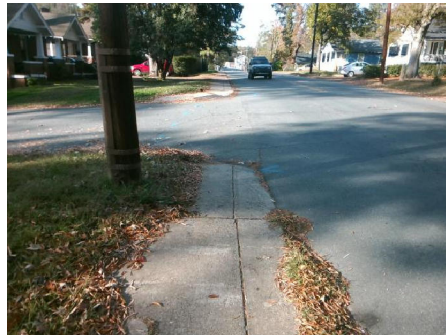
Compliance	Description	Data	Compliance	Description	Data
N/A	Ramp Length (in)	88.0	Yes	BlendTrans Slope (%)	0.0
No	Ramp Width (in)	37.0	Yes	BlendTrans XSlope (%)	0.2
N/A	Flare Type LT	N/A	N/A	Flare Type RT	N/A
N/A	Flare Slope LT (%)	N/A	N/A	Flare Slope RT (%)	N/A
N/A	Flare Traversable LT?	N/A	N/A	Flare Traversable RT?	N/A
N/A	Landing Length (in)	N/A	N/A	DWS Provided?	N/A
N/A	Landing Width (in)	N/A	N/A	DWS Contrast?	N/A
N/A	Landing Slope (%)	N/A	N/A	DWS Length (in)	N/A
N/A	Landing X Slope (%)	N/A	N/A	DWS Full Width?	N/A
N/A	Landing Curb? (Y/N)	N/A	N/A	DWS Offset (in)	N/A
N/A	Shared Landing?	N/A			
N/A	Gutter Ponding?	N/A	N/A	Gutter Slope (%)	N/A
N/A	Gutter Lip Ht (in)	0.5	N/A	Gutter X Slope (%)	N/A
N/A	Painted X Walk1?	No	N/A	Painted X Walk2?	N/A
	X Walk 1 Direction	To SW		X Walk 2 Direction	N/A
	X Walk 1 Width (in)	N/A		X Walk 2 Width (in)	N/A
	X Walk 1 Slope (%)	3.7		X Walk 2 Slope (%)	N/A
	X Walk 1 X Slope (%)	7.6		X Walk 2 X Slope (%)	N/A

N/A	Ramp inside XWalk1?	N/A	N/A	Ramp inside XWalk2?	N/A
	Road Slope (%)	7.6		Clear Space?	N/A
	Road X Slope (%)	3.7	N/A	Clear Space to XWalk (in)	N/A
N/A	Any Obstructions?	N/A	N/A	Storm Grate/Utility Hazard?	N/A
	Obstruction Type			Storm Grate/Utility Type	
		N/A			N/A
			Yes	Surface Condition? (G/P)	Good
			N/A	Curb Slope (%)	N/A

Remove & Replace Curb Ramp With Two New Directional Ramps or Equivalent.
