Access Compliance Report

Public Rights-of-Way

(Curb Ramps)

Intersection ID: 11122	Main Street: N_CHURCH_ST	Cross Street: W_15TH_ST	Location:	S
ADA ID: 3CCC25EC6066	Ramp Type: Directional1	Initial Pass/Fail: Fail	Overall Compliance: No	Severity Score: 15
Codes/Mitigation Info/Possible Solution		Field Measurements/Component Compliance

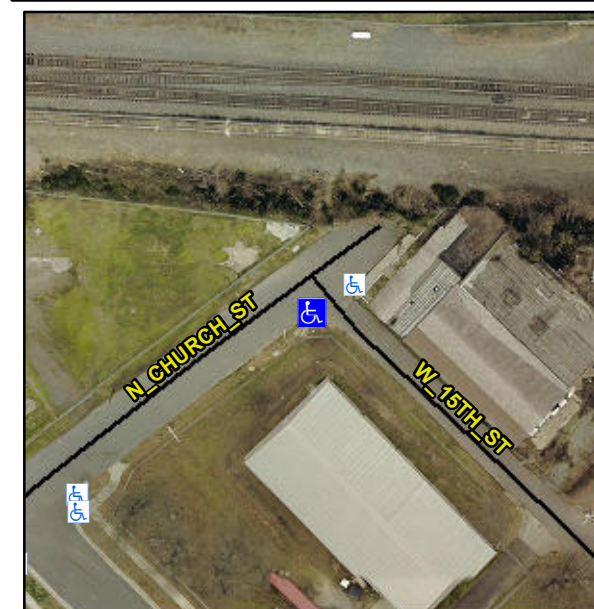
DAMAGED SURFACE

R302.7

Compliance	Description	Data	Compliance	Description	Data
N/A	Ramp Length (in)	59.0	N/A	Grade Break?	N/A
Yes	Ramp Width (in)	60.0	N/A	Grade Break Slope (%)	0.0
Yes	Ramp Slope (%)	6.0	N/A	Grade Break XSlope (%)	0.0
Yes	Ramp XSlope (%)	1.1			
N/A	Flare Type LT	N/A	N/A	Flare Type RT	N/A
N/A	Flare Slope LT (%)	N/A	N/A	Flare Slope RT (%)	0.0
N/A	Flare Traversable LT?	N/A	N/A	Flare Traversable RT?	N/A
N/A	Landing Length (in)	0.0	N/A	DWS Provided?	N/A
N/A	Landing Width (in)	0.0	N/A	DWS Contrast?	N/A
N/A	Landing Slope (%)	0.0	N/A	DWS Length (in)	N/A
N/A	Landing X Slope (%)	0.0	N/A	DWS Full Width?	N/A
N/A	Landing Curb? (Y/N)	N/A	N/A	DWS Offset LT (in)	N/A
N/A	Shared Landing?	N/A	N/A	DWS Offset RT (in)	N/A
N/A	Gutter Ponding?	0.0	N/A	Gutter Slope (%)	N/A
N/A	Gutter Lip Ht (in)	1.5	N/A	Gutter X Slope (%)	N/A
N/A	Painted X Walk1?	No		Road Slope (%)	0.8
	X Walk 1 Direction	To NE		Road X Slope (%)	3.7
	X Walk 1 Width (in)	N/A		Clear Space?	N/A

X Walk 1 Slope (%)	0.8	N/A	Clear Space to XWalk (in)	N/A
	X Walk 1 X Slope (%)	3.7	N/A	Storm Grate/Utility Hazard?	N/A
N/A	Ramp inside XWalk1?	N/A		Storm Grate/Utility Type	
N/A	Any Obstructions?	N/A			N/A
	Obstruction Type		No	Surface Condition? (G/P)	Poor
			N/A	Curb Slope (%)	N/A

Remove & Replace Entire Ramp.
