# Access Compliance Report

## Public Rights-of-Way

### (Curb Ramps)

Intersection ID: 7466	Main Street: S I-85 EXIT 39 RA	Cross Street: STATESVILLE RD	Location: SE
ADA ID: 3CD1B59A66BA	Ramp Type: Perp	Initial Pass/Fail: Fail	Overall Compliance: No
			Severity Score: 21.25

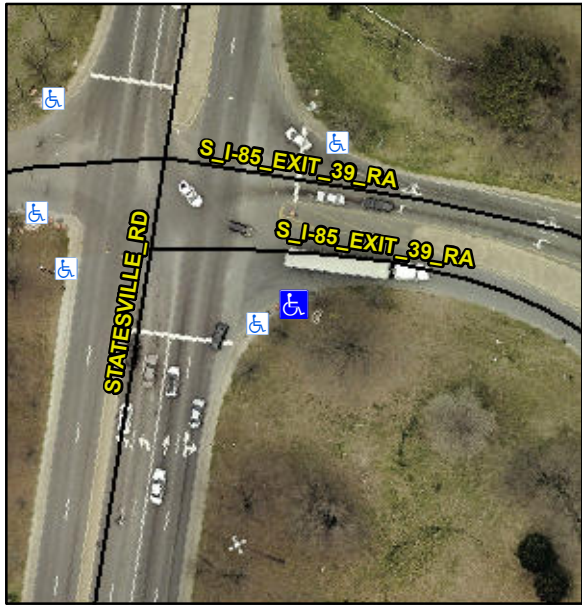
Possible Solutions:		Compliance	Description	Data	Compliance	Description	Data
	Remove & Replace Entire Ramp.		N/A	Ramp Length (in)	60.0	Yes	Ramp Slope (%)	8.1
			No	Ramp Width (in)	40.0	No	Ramp XSlope (%)	5.2
			N/A	Flare Type LT	N/A	N/A	Flare Type RT	N/A
			N/A	Flare Slope LT (%)	N/A	N/A	Flare Slope RT (%)	N/A
			N/A	Flare Traversable LT?	N/A	N/A	Flare Traversable RT?	N/A
			N/A	Landing Length (in)	N/A	N/A	DWS Provided?	N/A
			N/A	Landing Width (in)	N/A	N/A	DWS Contrast?	N/A
			N/A	Landing Slope (%)	N/A	N/A	DWS Length (in)	N/A
			N/A	Landing X Slope (%)	N/A	N/A	DWS Full Width?	N/A
<p>Surveyor Notes:</p> <p>N/A</p> <p>PROW/ADA:</p> <p>Not Found, R304.5.1, R304.5.3</p>			N/A	Landing Curb? (Y/N)	N/A	N/A	DWS Offset (in)	N/A
			N/A	Shared Landing?	N/A			
			N/A	Gutter Ponding?	N/A	N/A	Gutter Slope (%)	N/A
			N/A	Gutter Lip Ht (in)	N/A	N/A	Gutter X Slope (%)	N/A

N/A	Painted X Walk1?	No	N/A	Painted X Walk2?	N/A
				X Walk 1 Direction	To NE		X Walk 2 Direction	N/A
			N/A	X Walk 1 Width (in)	N/A	N/A	X Walk 2 Width (in)	N/A
				X Walk 1 Slope (%)	2.8		X Walk 2 Slope (%)	N/A
				X Walk 1 X Slope (%)	5.1		X Walk 2 X Slope (%)	N/A
			N/A	Ramp inside XWalk1?	N/A	N/A	Ramp inside XWalk2?	N/A
<p>Total Cost:</p> <p>\$ 1850.00</p>				Road Slope (%)	N/A	N/A	Clear Space?	N/A
				Road X Slope (%)	N/A	N/A	Clear Space to XWalk (in)	N/A
			N/A	Any Obstructions?	N/A	N/A	Storm Grate/Utility Hazard?	N/A
				Obstruction Type			Storm Grate/Utility Type	
					N/A			N/A
						Yes	Surface Condition? (G/P)	Good
