Access Compliance Report

Public Rights-of-Way

(Curb Ramps)

Intersection ID: 31540	Main Street: CALDWELL RIDGE PY	Cross Street: CARLEEN WAY DR	Location:	N
ADA ID: 3CD3A694BA94	Ramp Type: PerpDiag	Initial Pass/Fail: Fail	Overall Compliance: No	Severity Score: 8.75
Codes/Mitigation Info/Possible Solution		Field Measurements/Component Compliance

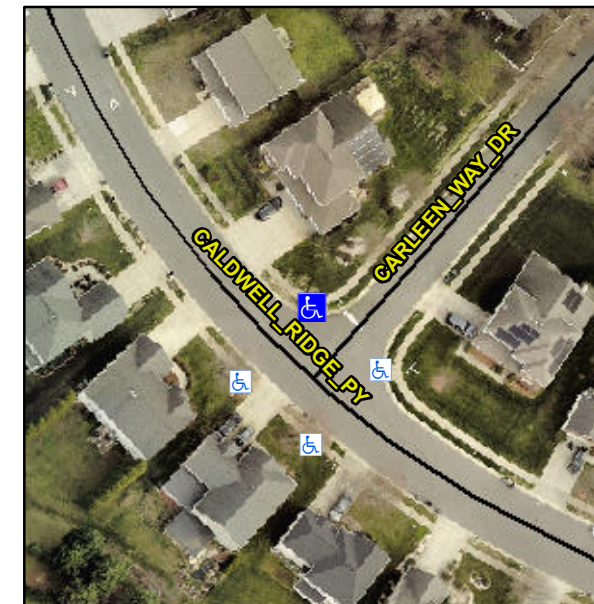
Not Found, R304.5.1

Compliance	Description	Data	Compliance	Description	Data
N/A	Ramp Length (in)	48.0	Yes	Ramp Slope (%)	5.2
No	Ramp Width (in)	46.0	Yes	Ramp XSlope (%)	1.7
N/A	Flare Type LT	N/A	N/A	Flare Type RT	N/A
N/A	Flare Slope LT (%)	N/A	N/A	Flare Slope RT (%)	N/A
N/A	Flare Traversable LT?	N/A	N/A	Flare Traversable RT?	N/A
N/A	Landing Length (in)	N/A	N/A	DWS Provided?	N/A
N/A	Landing Width (in)	N/A	N/A	DWS Contrast?	N/A
N/A	Landing Slope (%)	N/A	N/A	DWS Length (in)	N/A
N/A	Landing X Slope (%)	N/A	N/A	DWS Full Width?	N/A
N/A	Landing Curb? (Y/N)	N/A	N/A	DWS Offset (in)	N/A
N/A	Shared Landing?	N/A			
N/A	Gutter Ponding?	N/A	N/A	Gutter Slope (%)	N/A
N/A	Gutter Lip Ht (in)	N/A	N/A	Gutter X Slope (%)	N/A
N/A	Painted X Walk1?	No	N/A	Painted X Walk2?	No
	X Walk 1 Direction	To SW		X Walk 2 Direction	To SE
N/A	X Walk 1 Width (in)	N/A	N/A	X Walk 2 Width (in)	N/A
	X Walk 1 Slope (%)	7.0		X Walk 2 Slope (%)	5.1
	X Walk 1 X Slope (%)	2.0		X Walk 2 X Slope (%)	4.8

N/A	Ramp inside XWalk1?	N/A	N/A	Ramp inside XWalk2?	N/A
	Road Slope (%)	2.0	N/A	Clear Space?	N/A
	Road X Slope (%)	8.1	N/A	Clear Space to XWalk (in)	N/A
N/A	Any Obstructions?	N/A	N/A	Storm Grate/Utility Hazard?	N/A
	Obstruction Type			Storm Grate/Utility Type	
		N/A			N/A
			Yes	Surface Condition? (G/P)	Good

Remove & Replace Curb Ramp With Two New Directional Ramps or Equivalent.
