Access Compliance Report

Public Rights-of-Way

(Curb Ramps)

Intersection ID: 48948	Main Street: BIRCHLEY_CR	Cross Street: DAVID_JENNINGS_AV	Location:	N
ADA ID: 3CDB06CCDA58	Ramp Type: Combination1	Initial Pass/Fail: Fail	Overall Compliance: No	Severity Score: 21.25
Codes/Mitigation Info/Possible Solution		Field Measurements/Component Compliance

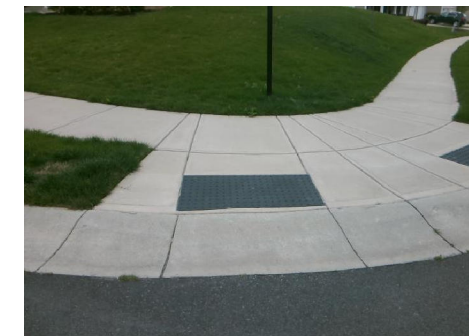
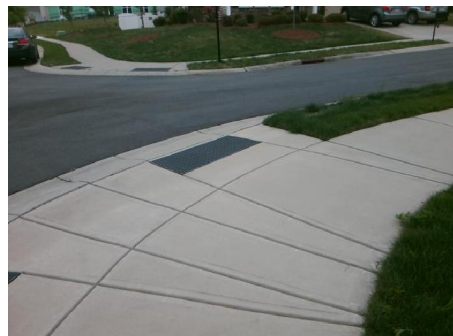
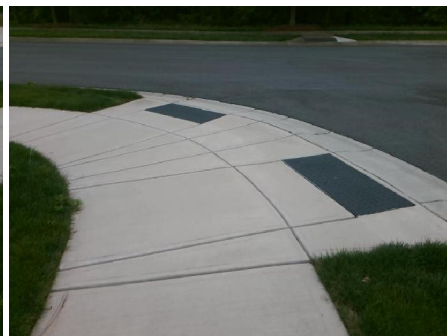
Not Found, R304.5.1, R304.5.3

Compliance	Description	Data	Compliance	Description	Data
N/A	Ramp Length LT (in)	6.5	N/A	Ramp Length RT (in)	7.5
Yes	Ramp Width LT (in)	60.0	Yes	Ramp Width RT (in)	60.0
Yes	Ramp Slope LT (%)	6.4	Yes	Ramp Slope RT (%)	5.6
Yes	Ramp XSlope LT (%)	0.7	Yes	Ramp XSlope RT (%)	1.3
N/A	Ramp Length (in)	47.5	Yes	Ramp Slope (%)	3.9
No	Ramp Width (in)	47.5	No	Ramp XSlope (%)	5.3
N/A	Flare Type LT	N/A	N/A	Flare Type RT	N/A
N/A	Flare Slope LT (%)	N/A	N/A	Flare Slope RT (%)	N/A
N/A	Flare Traversable LT?	N/A	N/A	Flare Traversable RT?	N/A
N/A	Landing Length (in)	N/A	N/A	DWS Provided?	N/A
N/A	Landing Width (in)	N/A	N/A	DWS Contrast?	N/A
N/A	Landing Slope (%)	N/A	N/A	DWS Length (in)	N/A
N/A	Landing X Slope (%)	N/A	N/A	DWS Full Width?	N/A
N/A	Landing Curb? (Y/N)	N/A	N/A	DWS Offset (in)	N/A
N/A	Shared Landing?	N/A			
N/A	Gutter Ponding?	N/A	N/A	Gutter Slope (%)	N/A
N/A	Gutter Lip Ht (in)	N/A	N/A	Gutter X Slope (%)	N/A
N/A	Painted X Walk1?	No	N/A	Painted X Walk2?	N/A

X Walk 1 Direction	To SW		X Walk 2 Direction	N/A
	X Walk 1 Width (in)	N/A		X Walk 2 Width (in)	N/A
	X Walk 1 Slope (%)	4.0		X Walk 2 Slope (%)	N/A
	X Walk 1 X Slope (%)	2.1		X Walk 2 X Slope (%)	N/A
N/A	Ramp inside XWalk1?	N/A	N/A	Ramp inside XWalk2?	N/A
	Road Slope (%)	N/A		Clear Space?	N/A
	Road X Slope (%)	N/A	N/A	Clear Space to XWalk (in)	N/A
			N/A	Any Obstruction?	N/A
				Obstruction Type	N/A
			N/A	Storm Grate/Utility Hazard?	N/A
				Storm Grate/Utility Type	N/A
			Yes	Surface Condition? (G/P)	Good
				Curb Slope (%)	24.1

Remove & Replace Entire Ramp.
