Access Compliance Report Public Rights-of-Way (Curb Ramps)

Intersection ID: 10041617 Main Street: WHITEBURN_CT Cross Street: N/A Location: SE ADA ID: 3CE67D45A388 Ramp Type: Perp Initial Pass/Fail: Fail **Overall Compliance: No Severity Score:** 12.5

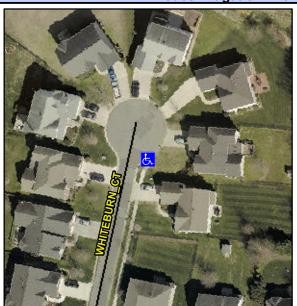
Field Measurements/Component Compilance								
Comp	iance Description	Data	Comp	liance Description	Data			
N/A	Ramp Length (in)	48.0	No	Ramp Slope (%)	9.0			
Yes	Ramp Width (in)	48.0	Yes	Ramp XSlope (%)	0.1			
N/A	Flare Type LT	N/A	N/A	Flare Type RT	N/A			
N/A	Flare Slope LT (%)	N/A	N/A	Flare Slope RT (%)	N/A			
N/A	Flare Traversable LT?	N/A	N/A	Flare Traversable RT?	N/A			
N/A	Landing Length (in)	N/A	N/A	DWS Provided?	N/A			
N/A	Landing Width (in)	N/A	N/A	DWS Contrast?	N/A			
N/A	Landing Slope (%)	N/A	N/A	DWS Length (in)	N/A			
N/A	Landing X Slope (%)	N/A	N/A	DWS Full Width?	N/A			
N/A	Landing Curb? (Y/N)	N/A	N/A	DWS Offset (in)	N/A			
N/A	Shared Landing?	N/A						
N/A	Gutter Ponding?	N/A	N/A	Gutter Slope (%)	N/A			
N/A	Gutter Lip Ht (in)	N/A	N/A	Gutter X Slope (%)	N/A			
N/A	Painted X Walk1?	No	N/A	Painted X Walk2?	N/A			
	X Walk 1 Direction	To NW		X Walk 2 Direction	N/A			
N/A	X Walk 1 Width (in)	N/A	N/A	X Walk 2 Width (in)	N/A

X Walk 1 Slope (%)	3.0		X Walk 2 Slope (%)	N/A			
	X Walk 1 X Slope (%)	0.5		X Walk 2 X Slope (%)	N/A			
N/A	Ramp inside XWalk1?	N/A	N/A	Ramp inside XWalk2?	N/A			
	Road Slope (%)	N/A	N/A	Clear Space?	N/A			
	Road X Slope (%)	N/A	N/A	Clear Space to XWalk (in)	N/A			
N/A	Any Obstructions?	N/A	N/A	Storm Grate/Utility Hazard?	N/A			
	Obstruction Type			Storm Grate/Utility Type				
		N/A			N/A			
			Yes	Surface Condition? (G/P)	Good

<u>)</u>	Possible Solution	
2	Possible Solutions:	<u>c</u>
1	Remove & Replace Entire Ramp.	N
		Υ
		N
		N
1		N
S. All		N
S. of Edit	Surveyor Notes:	N
1	N/A	N
No.		N
		N
		N
į	PROW/ADA:	N
1000	Not Found, R304.2.2	N
		N
4		
		N
		N
