Access Compliance Report

Public Rights-of-Way

(Curb Ramps)

Intersection ID: 31637	Main Street: JAMES_RD	Cross Street: MARY_JO_HELMS_DR	Location: NW
ADA ID: 3CE8EAC5EE8D	Ramp Type: Combination1	Initial Pass/Fail: Fail	Overall Compliance: No
			Severity Score: 58.75

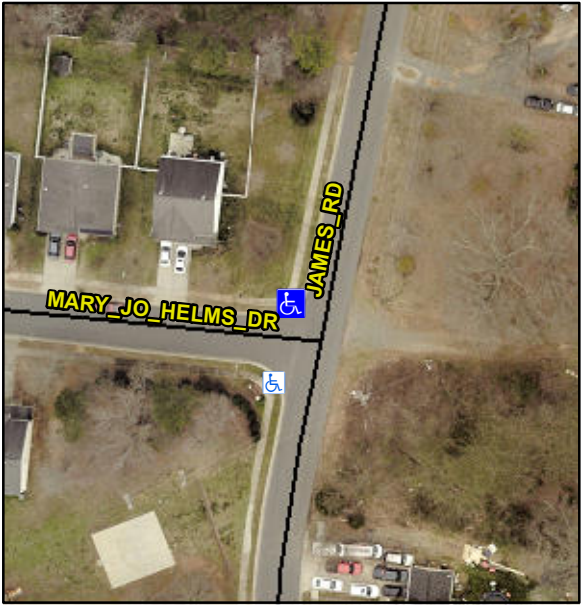
Possible Solutions:		Compliance	Description	Data	Compliance
	Remove & Replace Entire Ramp.		N/A	Ramp Length LT (in)	39.0	N/A
			Yes	Ramp Width LT (in)	49.0	Yes
			No	Ramp Slope LT (%)	8.8	No
			Yes	Ramp XSlope LT (%)	1.7	No
			N/A	Ramp Length (in)	46.0	No
			No	Ramp Width (in)	38.0	No
			N/A	Flare Type LT	N/A	N/A
			N/A	Flare Slope LT (%)	N/A	N/A
			N/A	Flare Traversable LT?	N/A	N/A
<p>Surveyor Notes:</p> <p>N/A</p> <p>PROW/ADA:</p> <p>Not Found, R304.5.1, R304.2.2, R304.5.3, R304.3.2</p>			N/A	Ramp Slope RT (%)	16.1	No
			No	Ramp XSlope RT (%)	5.1	No
			N/A	Ramp Slope (%)	10.8	No
			No	Ramp XSlope (%)	8.0	No
			N/A	Flare Type RT	N/A	N/A
			N/A	Flare Slope RT (%)	N/A	N/A
			N/A	Flare Traversable RT?	N/A	N/A
			N/A	DWS Provided?	N/A	N/A
			N/A	DWS Contrast?	N/A	N/A
			N/A	DWS Length (in)	N/A	N/A
<p>Street 1 Name</p> <p>Stop Condition-Street 1</p> <p>Street 2 Name</p> <p>Stop Condition-Street 2</p>			N/A	DWS Full Width?	N/A	N/A

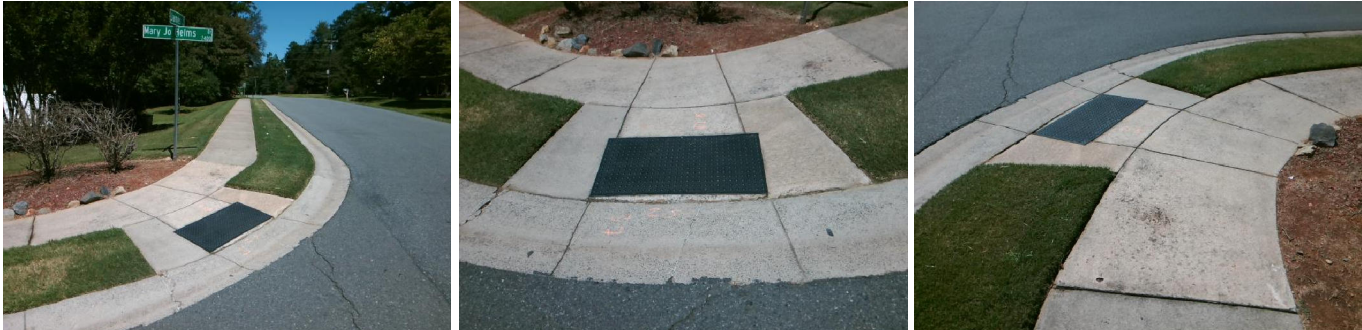
N/A	DWS Offset (in)	N/A	N/A
			N/A	Gutter Slope (%)	N/A	N/A
			N/A	Gutter Lip Ht (in)	N/A	N/A
			N/A	Painted X Walk1?	No	N/A
				X Walk 1 Direction	To S	N/A
				X Walk 1 Width (in)	N/A	N/A
				X Walk 1 Slope (%)	3.7	N/A
				X Walk 1 X Slope (%)	2.5	N/A
			N/A	Ramp inside XWalk1?	N/A	N/A
<p>Total Cost:</p> <p>\$ 1800.00</p>			N/A	Ramp inside XWalk2?	N/A	N/A
				Road Slope (%)	N/A	N/A
				Road X Slope (%)	N/A	N/A
			N/A	Clear Space?	N/A	N/A
			N/A	Clear Space to XWalk (in)	N/A	N/A
			N/A	Any Obstruction?	N/A	N/A
				Obstruction Type		N/A
			N/A	Storm Grate/Utility Hazard?	N/A	N/A
				Storm Grate/Utility Type		N/A
			Yes	Surface Condition? (G/P)	Good	Good

Curb Slope (%)	10.1
