# Access Compliance Report

## Public Rights-of-Way

### (Curb Ramps)

Intersection ID: N/A	Main Street: NEW_FASHION_WY	Cross Street: N/A	Location: NW
ADA ID: 3CE908D7A460	Ramp Type: Perp	Initial Pass/Fail: Fail	Overall Compliance: No
Severity Score: 33.75			
Codes/Mitigation Info/Possible Solution		Field Measurements/Component Compliance

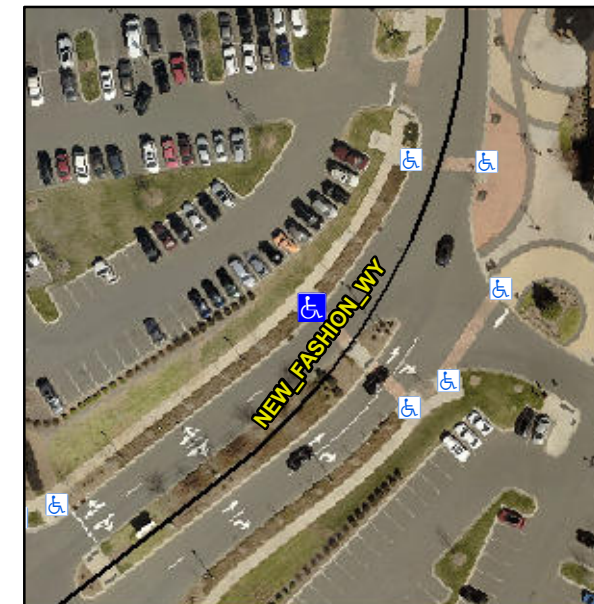
Compliance	Description	Data	Compliance	Description	Data
N/A	Ramp Length (in)	97.0	Yes	Ramp Slope (%)	6.8
No	Ramp Width (in)	45.0	No	Ramp XSlope (%)	7.7
N/A	Flare Type LT	N/A	N/A	Flare Type RT	N/A
N/A	Flare Slope LT (%)	N/A	N/A	Flare Slope RT (%)	N/A
N/A	Flare Traversable LT?	N/A	N/A	Flare Traversable RT?	N/A
N/A	Landing Length (in)	N/A	N/A	DWS Provided?	N/A
N/A	Landing Width (in)	N/A	N/A	DWS Contrast?	N/A
N/A	Landing Slope (%)	N/A	N/A	DWS Length (in)	N/A
N/A	Landing X Slope (%)	N/A	N/A	DWS Full Width?	N/A
N/A	Landing Curb? (Y/N)	N/A	N/A	DWS Offset (in)	N/A
N/A	Shared Landing?	N/A			
N/A	Gutter Ponding?	N/A	N/A	Gutter Slope (%)	N/A
N/A	Gutter Lip Ht (in)	N/A	N/A	Gutter X Slope (%)	N/A
N/A	Painted X Walk1?	Yes	N/A	Painted X Walk2?	N/A
	X Walk 1 Direction	To SE		X Walk 2 Direction	N/A
N/A	X Walk 1 Width (in)	80.0	N/A	X Walk 2 Width (in)	N/A
	X Walk 1 Slope (%)	3.1		X Walk 2 Slope (%)	N/A
	X Walk 1 X Slope (%)	8.1		X Walk 2 X Slope (%)	N/A

N/A	Ramp inside XWalk1?	Yes	N/A	Ramp inside XWalk2?	N/A
	Road Slope (%)	N/A	N/A	Clear Space?	N/A
	Road X Slope (%)	N/A	N/A	Clear Space to XWalk (in)	N/A
N/A	Any Obstructions?	N/A	N/A	Storm Grate/Utility Hazard?	N/A
	Obstruction Type			Storm Grate/Utility Type	
		N/A			N/A
		Yes		Surface Condition? (G/P)	Good

Possible Solutions:

**Remove & Replace Entire Ramp.**

**R304.5.1, R304.5.3**

Total Cost: \$ 1850.00
