Access Compliance Report Public Rights-of-Way (Curb Ramps)

Intersection ID: 10862 Main Street: N_GRAHAM_ST Cross Street: DALTON_AV Location: NW

ADA ID: 3CECF7E17983 Ramp Type: BlendTrans1 Initial Pass/Fail: Fail Overall Compliance: No Severity Score: 8.75

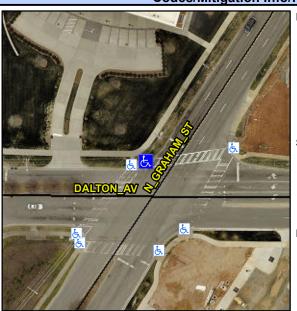
PROW/ADA:
Not Found, R304.5.1

Field Measurements/Component Compliance					
Compliance Description		Data	Compliance Description		Data
N/A	Ramp Length (in)	144.5	Yes	BlendTrans Slope (%)	2.9
No	Ramp Width (in)	47.5	Yes	BlendTrans XSlope (%)	0.8
N/A	A Flare Type LT	N/A	N/A	Flare Type RT	N/A
N/A	Flare Slope LT (%)	N/A	N/A	Flare Slope RT (%)	N/A
N/A	Flare Traversable LT?	N/A	N/A	Flare Traversable RT?	N/A
N/A	Landing Length (in)	N/A	N/A	DWS Provided?	N/A
N/A	Landing Width (in)	N/A	N/A	DWS Contrast?	N/A
N/A	Landing Slope (%)	N/A	N/A	DWS Length (in)	N/A
N/A	Landing X Slope (%)	N/A	N/A	DWS Full Width?	N/A
N/A	Landing Curb? (Y/N)	N/A	N/A	DWS Offset (in)	N/A
N/A	A Shared Landing?	N/A			
N/A	A Gutter Ponding?	N/A	N/A	Gutter Slope (%)	N/A
N/A	Gutter Lip Ht (in)	N/A	N/A	Gutter X Slope (%)	N/A
N/A	A Painted X Walk1?	Yes	N/A	Painted X Walk2?	N/A
	X Walk 1 Direction	To NE		X Walk 2 Direction	N/A
	X Walk 1 Width (in)	119.0		X Walk 2 Width (in)	N/A
	X Walk 1 Slope (%)	5.4		X Walk 2 Slope (%)	N/A

X Walk 1 X Slope (%)	1.8		X Walk 2 X Slope (%)	N/A
N/A	A Ramp inside XWalk1?	Yes	N/A	Ramp inside XWalk2?	N/A
	Road Slope (%)	1.8		Clear Space?	N/A
	Road X Slope (%)	5.4	N/A	Clear Space to XWalk (in)	N/A
N/A	Any Obstructions?	N/A	N/A	Storm Grate/Utility Hazard?	N/A
	Obstruction Type			Storm Grate/Utility Type	
		N/A			N/A
			Yes	Surface Condition? (G/P)	Good
			No	Curb Slope (%)	13.5
The last last

Remove & Replace Curb Ramp With
Two New Directional Ramps or
Equivalent.
