# Access Compliance Report

## Public Rights-of-Way

### (Curb Ramps)

| Intersection ID: 47113 | Main Street: ELIZABETH_OAKS_AV | Cross Street: TINDLE_HILL_LN | Location: W |

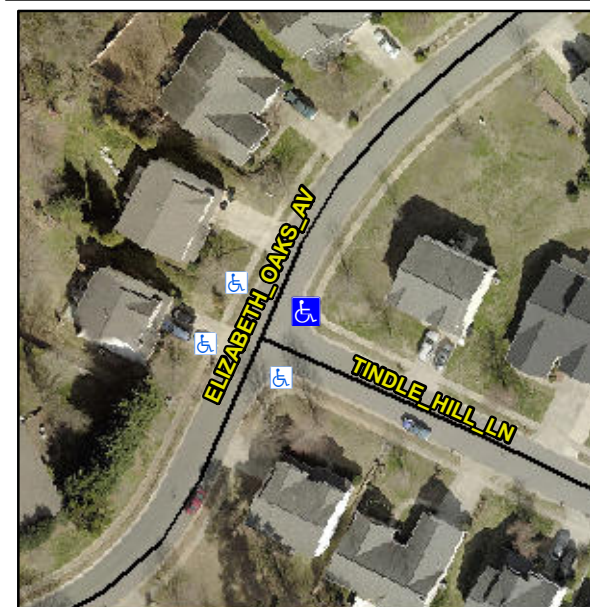
**Not Found, R304.5.1**

| Compliance | Description | Data | Compliance | Description | Data |
|---|---|---|---|---|---|
| No | Ramp Width (in) | 47.0 | Yes | Ramp XSlope (%) | 1.4 |

**Remove & Replace Curb Ramp With Two New Directional Ramps or Equivalent.**

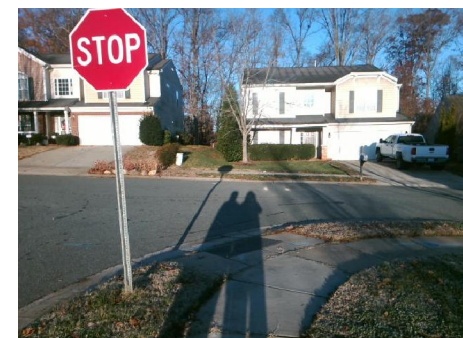
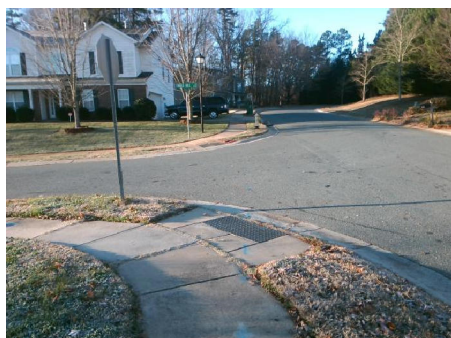
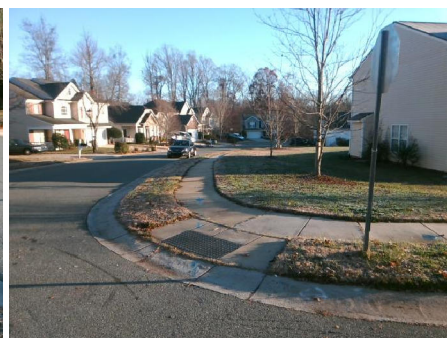
| Compliance | Description | Data | Compliance | Description | Data |
|---|---|---|---|---|---|
| | | | Yes | Surface Condition? (G/P) | Good |
