Access Compliance Report

Public Rights-of-Way

(Curb Ramps)

Intersection ID: 15897	Main Street: LOCKHART_DR	Cross Street: CLAYTON_DR	Location: NW
ADA ID: 3CFAEFA7B59F	Ramp Type: PerpDiag	Initial Pass/Fail: Fail	Overall Compliance: No
		Severity Score: 10

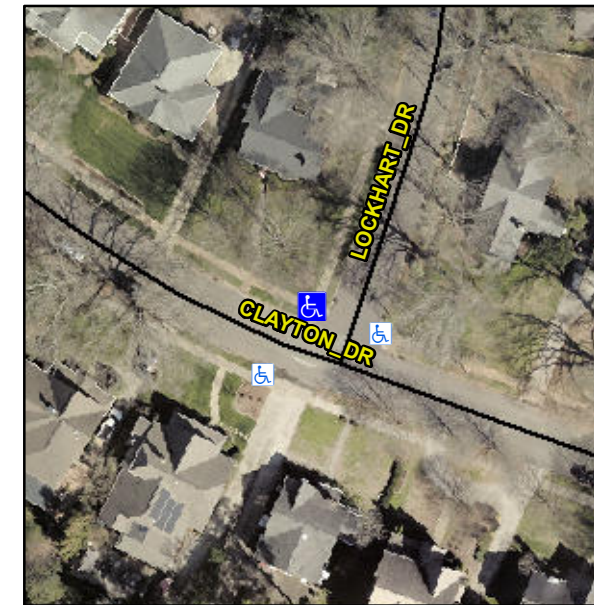
Compliance	Description	Data	Compliance	Description	Data
N/A	Ramp Length (in)	52.0	Yes	Ramp Slope (%)	6.3
No	Ramp Width (in)	43.0	No	Ramp XSlope (%)	2.2
N/A	Flare Type LT	N/A	N/A	Flare Type RT	N/A
N/A	Flare Slope LT (%)	N/A	N/A	Flare Slope RT (%)	N/A
N/A	Flare Traversable LT?	N/A	N/A	Flare Traversable RT?	N/A
N/A	Landing Length (in)	N/A	N/A	DWS Provided?	N/A
N/A	Landing Width (in)	N/A	N/A	DWS Contrast?	N/A
N/A	Landing Slope (%)	N/A	N/A	DWS Length (in)	N/A
N/A	Landing X Slope (%)	N/A	N/A	DWS Full Width?	N/A
N/A	Landing Curb? (Y/N)	N/A	N/A	DWS Offset (in)	N/A
N/A	Shared Landing?	N/A			
N/A	Gutter Ponding?	N/A	N/A	Gutter Slope (%)	N/A
N/A	Gutter Lip Ht (in)	N/A	N/A	Gutter X Slope (%)	N/A
N/A	Painted X Walk1?	No	N/A	Painted X Walk2?	No
	X Walk 1 Direction	To SW		X Walk 2 Direction	To SE
N/A	X Walk 1 Width (in)	N/A	N/A	X Walk 2 Width (in)	N/A
	X Walk 1 Slope (%)	0.9		X Walk 2 Slope (%)	3.5
	X Walk 1 X Slope (%)	3.4		X Walk 2 X Slope (%)	1.8

N/A	Ramp inside XWalk1?	N/A	N/A	Ramp inside XWalk2?	N/A
	Road Slope (%)	0.2	N/A	Clear Space?	N/A
	Road X Slope (%)	0.1	N/A	Clear Space to XWalk (in)	N/A
N/A	Any Obstructions?	N/A	N/A	Storm Grate/Utility Hazard?	N/A
	Obstruction Type			Storm Grate/Utility Type	
		N/A			N/A
			Yes	Surface Condition? (G/P)	Good

Remove & Replace Curb Ramp With Two New Directional Ramps or Equivalent.

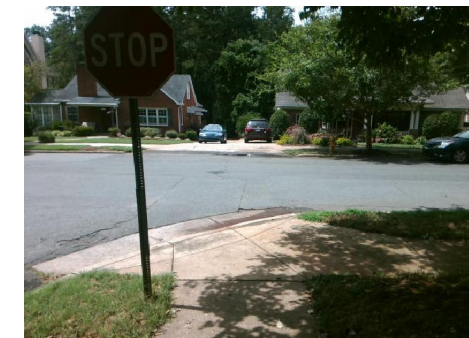
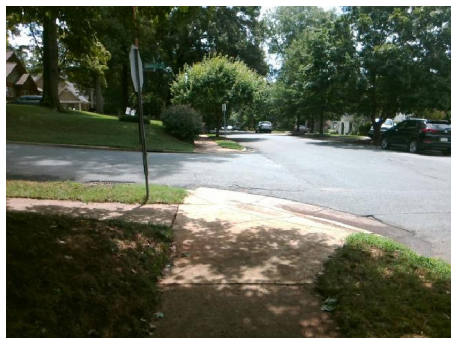
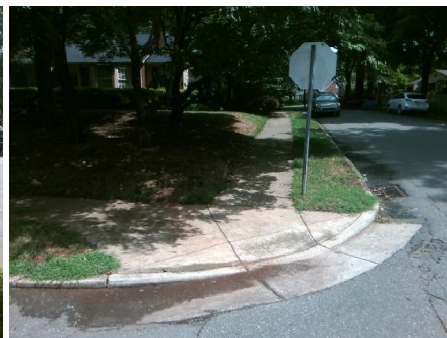
Street 1 Name **CLAYTON DR**
 Stop Condition-Street 2 **None**
 Street 2 Name **LOCKHART DR**
 Stop Condition-Street 1 **StopSign**
