# Access Compliance Report

## Public Rights-of-Way

### (Curb Ramps)

Intersection ID: 5318	Main Street: CARRONBRIDGE_LN	Cross Street: SUNSET_RD	Location:	N
ADA ID: 3D03FD850B58	Ramp Type: Perp	Initial Pass/Fail: Fail	Overall Compliance: No	Severity Score: 26.25

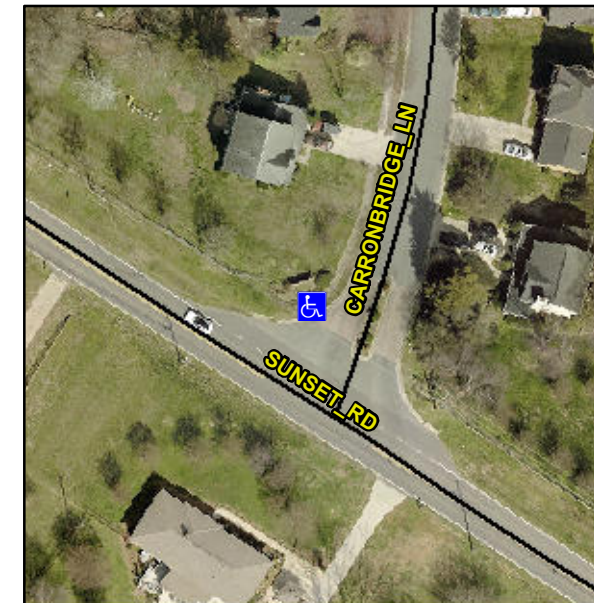
Compliance	Description	Data	Compliance	Description	Data
N/A	Ramp Length (in)	46.5	No	Ramp Slope (%)	12.4
Yes	Ramp Width (in)	48.0	Yes	Ramp XSlope (%)	2.5
N/A	Flare Type LT	N/A	N/A	Flare Type RT	N/A
N/A	Flare Slope LT (%)	N/A	N/A	Flare Slope RT (%)	N/A
N/A	Flare Traversable LT?	N/A	N/A	Flare Traversable RT?	N/A
N/A	Landing Length (in)	N/A	N/A	DWS Provided?	N/A
N/A	Landing Width (in)	N/A	N/A	DWS Contrast?	N/A
N/A	Landing Slope (%)	N/A	N/A	DWS Length (in)	N/A
N/A	Landing X Slope (%)	N/A	N/A	DWS Full Width?	N/A
N/A	Landing Curb? (Y/N)	N/A	N/A	DWS Offset (in)	N/A
N/A	Shared Landing?	N/A			
N/A	Gutter Ponding?	N/A	N/A	Gutter Slope (%)	N/A
N/A	Gutter Lip Ht (in)	N/A	N/A	Gutter X Slope (%)	N/A
N/A	Painted X Walk1?	No	N/A	Painted X Walk2?	N/A
	X Walk 1 Direction	To S		X Walk 2 Direction	N/A
N/A	X Walk 1 Width (in)	N/A	N/A	X Walk 2 Width (in)	N/A
	X Walk 1 Slope (%)	3.5		X Walk 2 Slope (%)	N/A
	X Walk 1 X Slope (%)	3.3		X Walk 2 X Slope (%)	N/A

N/A	Ramp inside XWalk1?	N/A	N/A	Ramp inside XWalk2?	N/A
	Road Slope (%)	3.3	N/A	Clear Space?	N/A
	Road X Slope (%)	3.5	N/A	Clear Space to XWalk (in)	N/A
N/A	Any Obstructions?	N/A	N/A	Storm Grate/Utility Hazard?	N/A
	Obstruction Type			Storm Grate/Utility Type	
		N/A			N/A
			Yes	Surface Condition? (G/P)	Good

**Remove & Replace Entire Ramp.**
