Access Compliance Report

Public Rights-of-Way

(Curb Ramps)

Intersection ID: N/A	Main Street: TYVOLA_RD	Cross Street: I-77	Location: NE
ADA ID: 3D0A5C3C6EAE	Ramp Type: BlendTrans1	Initial Pass/Fail: Fail	Overall Compliance: No
		Severity Score: 15

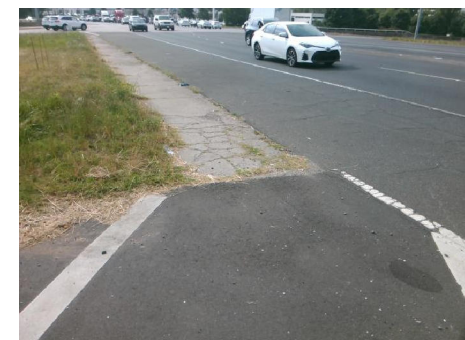
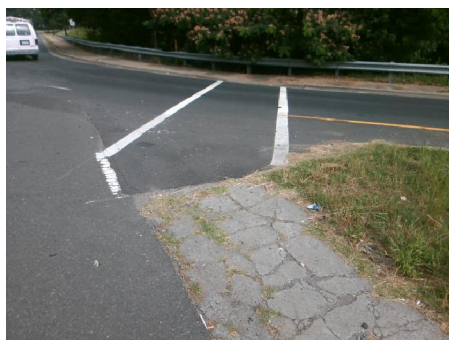
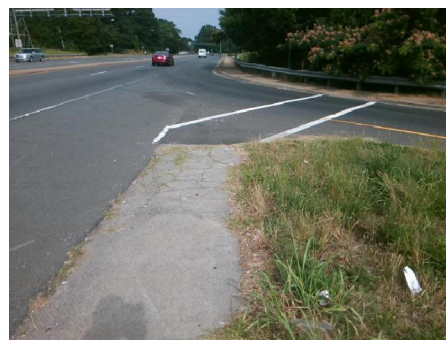
Not Found, R302.7

N/A	Ramp inside XWalk1?	Yes	N/A	Ramp inside XWalk2?	N/A
	Road Slope (%)	0.5		Clear Space?	N/A
	Road X Slope (%)	0.9	N/A	Clear Space to XWalk (in)	N/A
N/A	Any Obstructions?	N/A	N/A	Storm Grate/Utility Hazard?	N/A
	Obstruction Type			Storm Grate/Utility Type	
		N/A			N/A
			No	Surface Condition? (G/P)	Poor
			No	Curb Slope (%)	5.7

Remove & Replace Curb Ramp With Two New Directional Ramps or Equivalent.
