Access Compliance Report

Public Rights-of-Way

(Curb Ramps)

Intersection ID: 50320	Main Street: BRYN_ATHYN_CT	Cross Street: CINDY_LN	Location: NE
ADA ID: 3D1676013F96	Ramp Type: Directional1	Initial Pass/Fail: Fail	Overall Compliance: No
			Severity Score: 13.75

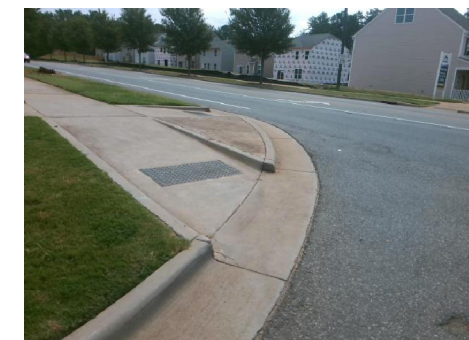
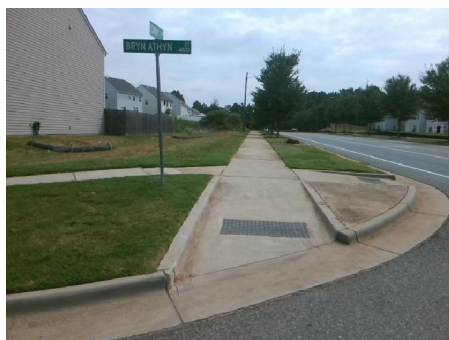
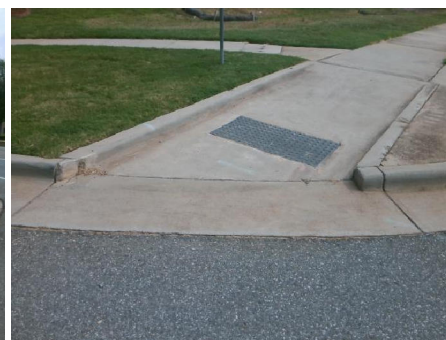
Compliance	Description	Data	Compliance	Description	Data
N/A	Ramp Length (in)	141.0	N/A	Grade Break?	N/A
Yes	Ramp Width (in)	72.5	N/A	Grade Break Slope (%)	0.0
No	Ramp Slope (%)	8.8	N/A	Grade Break XSlope (%)	0.0
No	Ramp XSlope (%)	2.4			
N/A	Flare Type LT	N/A	N/A	Flare Type RT	N/A
N/A	Flare Slope LT (%)	N/A	N/A	Flare Slope RT (%)	0.0
N/A	Flare Traversable LT?	N/A	N/A	Flare Traversable RT?	N/A
N/A	Landing Length (in)	0.0	N/A	DWS Provided?	N/A
N/A	Landing Width (in)	0.0	N/A	DWS Contrast?	N/A
N/A	Landing Slope (%)	0.0	N/A	DWS Length (in)	N/A
N/A	Landing X Slope (%)	0.0	N/A	DWS Full Width?	N/A
N/A	Landing Curb? (Y/N)	N/A	N/A	DWS Offset LT (in)	N/A
N/A	Shared Landing?	N/A	N/A	DWS Offset RT (in)	N/A
N/A	Gutter Ponding?	0.0	N/A	Gutter Slope (%)	N/A
N/A	Gutter Lip Ht (in)	0.0	N/A	Gutter X Slope (%)	N/A
N/A	Painted X Walk1?	No		Road Slope (%)	2.2
	X Walk 1 Direction	To NW		Road X Slope (%)	4.4
	X Walk 1 Width (in)	N/A		Clear Space?	N/A

X Walk 1 Slope (%)	2.2	N/A	Clear Space to XWalk (in)	N/A
	X Walk 1 X Slope (%)	4.4	N/A	Storm Grate/Utility Hazard?	N/A
N/A	Ramp inside XWalk1?	N/A		Storm Grate/Utility Type	
N/A	Any Obstructions?	N/A			N/A
	Obstruction Type		Yes	Surface Condition? (G/P)	Good
			N/A	Curb Slope (%)	N/A

Remove & Replace Entire Ramp.
